Access Compliance Report

Public Rights-of-Way

(Curb Ramps)

Intersection ID: 14342	Main Street: LILLINGTON_AV	Cross Street: AMHERST_PL	Location:	E
ADA ID: FE507C87F8E8	Ramp Type: PerpDiag	Initial Pass/Fail: Fail	Overall Compliance: No	Severity Score: 10

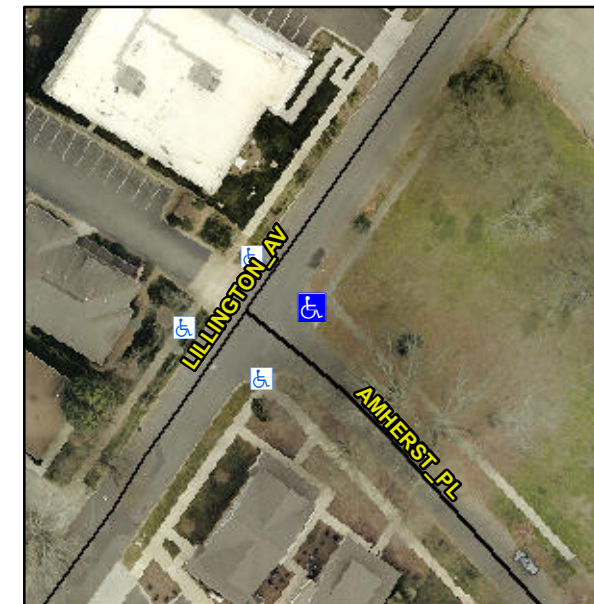
Compliance	Description	Data	Compliance	Description	Data
N/A	Ramp Length (in)	68.0	Yes	Ramp Slope (%)	5.3
No	Ramp Width (in)	46.0	No	Ramp XSlope (%)	2.6
N/A	Flare Type LT	N/A	N/A	Flare Type RT	N/A
N/A	Flare Slope LT (%)	N/A	N/A	Flare Slope RT (%)	N/A
N/A	Flare Traversable LT?	N/A	N/A	Flare Traversable RT?	N/A
N/A	Landing Length (in)	N/A	N/A	DWS Provided?	N/A
N/A	Landing Width (in)	N/A	N/A	DWS Contrast?	N/A
N/A	Landing Slope (%)	N/A	N/A	DWS Length (in)	N/A
N/A	Landing X Slope (%)	N/A	N/A	DWS Full Width?	N/A
N/A	Landing Curb? (Y/N)	N/A	N/A	DWS Offset (in)	N/A
N/A	Shared Landing?	N/A			
N/A	Gutter Ponding?	N/A	N/A	Gutter Slope (%)	N/A
N/A	Gutter Lip Ht (in)	N/A	N/A	Gutter X Slope (%)	N/A
N/A	Painted X Walk1?	No	N/A	Painted X Walk2?	No
	X Walk 1 Direction	To NW		X Walk 2 Direction	To SW
N/A	X Walk 1 Width (in)	N/A	N/A	X Walk 2 Width (in)	N/A
	X Walk 1 Slope (%)	1.8		X Walk 2 Slope (%)	0.8
	X Walk 1 X Slope (%)	2.0		X Walk 2 X Slope (%)	0.9

N/A	Ramp inside XWalk1?	N/A	N/A	Ramp inside XWalk2?	N/A
	Road Slope (%)	1.5	N/A	Clear Space?	N/A
	Road X Slope (%)	2.0	N/A	Clear Space to XWalk (in)	N/A
N/A	Any Obstructions?	N/A	N/A	Storm Grate/Utility Hazard?	N/A
	Obstruction Type			Storm Grate/Utility Type	
		N/A			N/A
			Yes	Surface Condition? (G/P)	Good

Remove & Replace Curb Ramp With Two New Directional Ramps or Equivalent.

R304.5.1, R304.5.3
