Access Compliance Report Public Rights-of-Way (Curb Ramps)

Intersection ID: 10663Main Street: FINCHLEY_DRCross Street: MIRAMAR_DRLocation:SWADA ID: FE533CC8273FRamp Type: Combination1Initial Pass/Fail: FailOverall Compliance: NoSeverity Score:22.5

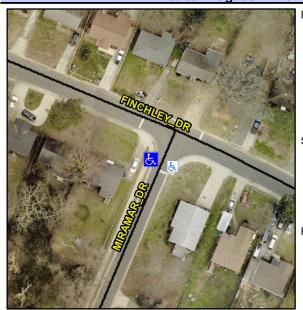
LT RP < 5%

Not Found, R304.5.1, R304.5.3, R304.3.2

Compliance Description Data Compliance Description Data Ramp Length LT (in) N/A N/A 68.5 Ramp Length RT (in) 58.0 Yes Ramp Width LT (in) 60.0 Yes Ramp Width RT (in) 60.5 Yes No Ramp Slope LT (%) 1.1 Ramp Slope RT (%) 11.7 Ramp XSlope LT (%) Yes Ramp XSlope RT (%) Yes 1.1 1.5 N/A Ramp Length (in) 36.0 Yes Ramp Slope (%) 0.6 47.5 No Ramp XSlope (%) 2.5 No Ramp Width (in) N/A Flare Type LT N/A N/A Flare Type RT N/A N/A N/A Flare Slope LT (%) N/A Flare Slope RT (%) N/A N/A Flare Traversable LT? N/A N/A Flare Traversable RT? N/A N/A Landing Length (in) N/A N/A DWS Provided? N/A N/A N/A N/A Landing Width (in) **DWS Contrast?** N/A N/A Landing Slope (%) N/A N/A DWS Length (in) N/A N/A Landing X Slope (%) N/A N/A DWS Full Width? N/A N/A Landing Curb? (Y/N) N/A N/A DWS Offset (in) N/A N/A Shared Landing? N/A N/A **Gutter Ponding?** N/A N/A Gutter Slope (%) N/A N/A N/A Gutter Lip Ht (in) N/A Gutter X Slope (%) N/A N/A Painted X Walk2? N/A Painted X Walk1? No N/A To SE X Walk 1 Direction X Walk 2 Direction N/A X Walk 1 Width (in) N/A X Walk 2 Width (in) N/A 4.7 N/A X Walk 1 Slope (%) X Walk 2 Slope (%) X Walk 1 X Slope (%) 3.4 X Walk 2 X Slope (%) N/A N/A Ramp inside XWalk1? N/A N/A Ramp inside XWalk2? N/A Road Slope (%) N/A Clear Space? N/A Road X Slope (%) N/A N/A Clear Space to XWalk (in) N/A

Remove & Replace Entire Ramp.
