# Access Compliance Report

## Public Rights-of-Way

| Intersection ID: 45518 | Main Street: COTTON_PRESS_RD | Cross Street: MEADOW_BOTTOM_RD | Location: W |
| ADA ID: FE619212613D | Ramp Type: PerpDiag | Initial Pass/Fail: Fail | Overall Compliance: No |

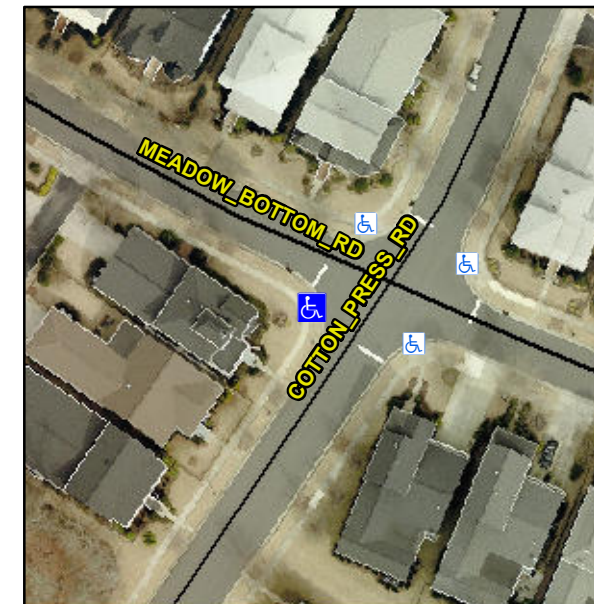
**Not Found, R304.5.1, R304.2.2**

| Compliance | Description | Data | Compliance | Description | Data |
|---|---|---|---|---|---|
| N/A | Ramp Length (in) | 72.0 | No | Ramp Slope (%) | 12.8 |
| No | Ramp Width (in) | 36.0 | Yes | Ramp XSlope (%) | 1.8 |

**Remove & Replace Curb Ramp With Two New Directional Ramps or Equivalent.**
