Access Compliance Report

Public Rights-of-Way

(Curb Ramps)

Intersection ID: 28174	Main Street: BLAKENEY_HEATH_RD	Cross Street: FIELDCROFT_DR	Location: SW
ADA ID: FE61F8C8FF42	Ramp Type: Perp	Initial Pass/Fail: Fail	Overall Compliance: No
Severity Score: 33.75			
Codes/Mitigation Info/Possible Solution		Field Measurements/Component Compliance

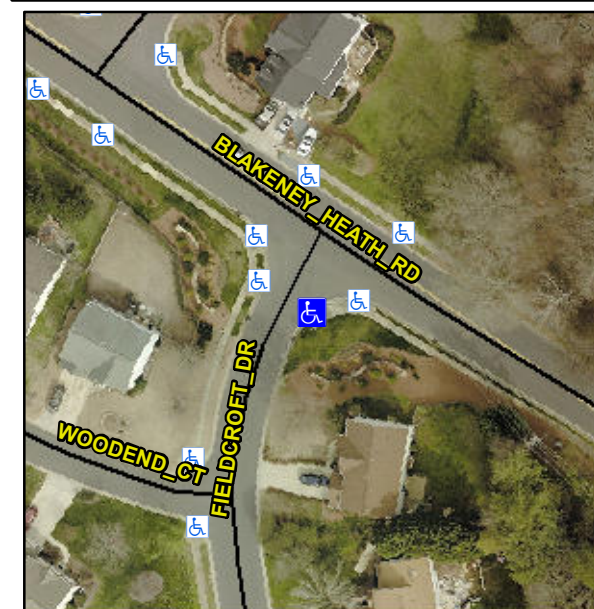
R304.5.1, R304.5.3

Compliance	Description	Data	Compliance	Description	Data
N/A	Ramp Length (in)	75.0	Yes	Ramp Slope (%)	7.1
No	Ramp Width (in)	41.0	No	Ramp XSlope (%)	7.6
N/A	Flare Type LT	N/A	N/A	Flare Type RT	N/A
N/A	Flare Slope LT (%)	N/A	N/A	Flare Slope RT (%)	N/A
N/A	Flare Traversable LT?	N/A	N/A	Flare Traversable RT?	N/A
N/A	Landing Length (in)	N/A	N/A	DWS Provided?	N/A
N/A	Landing Width (in)	N/A	N/A	DWS Contrast?	N/A
N/A	Landing Slope (%)	N/A	N/A	DWS Length (in)	N/A
N/A	Landing X Slope (%)	N/A	N/A	DWS Full Width?	N/A
N/A	Landing Curb? (Y/N)	N/A	N/A	DWS Offset (in)	N/A
N/A	Shared Landing?	N/A			
N/A	Gutter Ponding?	N/A	N/A	Gutter Slope (%)	N/A
N/A	Gutter Lip Ht (in)	N/A	N/A	Gutter X Slope (%)	N/A
N/A	Painted X Walk1?	No	N/A	Painted X Walk2?	N/A
	X Walk 1 Direction	To NW		X Walk 2 Direction	N/A
N/A	X Walk 1 Width (in)	N/A	N/A	X Walk 2 Width (in)	N/A
	X Walk 1 Slope (%)	4.7		X Walk 2 Slope (%)	N/A
	X Walk 1 X Slope (%)	4.6		X Walk 2 X Slope (%)	N/A

N/A	Ramp inside XWalk1?	N/A	N/A	Ramp inside XWalk2?	N/A
	Road Slope (%)	N/A	N/A	Clear Space?	N/A
	Road X Slope (%)	N/A	N/A	Clear Space to XWalk (in)	N/A
N/A	Any Obstructions?	N/A	N/A	Storm Grate/Utility Hazard?	N/A
	Obstruction Type			Storm Grate/Utility Type	
		N/A			N/A
			Yes	Surface Condition? (G/P)	Good

Remove & Replace Entire Ramp.

Total Cost: \$ 1850.00
