# Access Compliance Report

## Public Rights-of-Way

### (Curb Ramps)

| Intersection ID: 50100 | Main Street: PECAN_FLATS_DR | Cross Street: SUNRISE_VIEW_DR | Location: W |

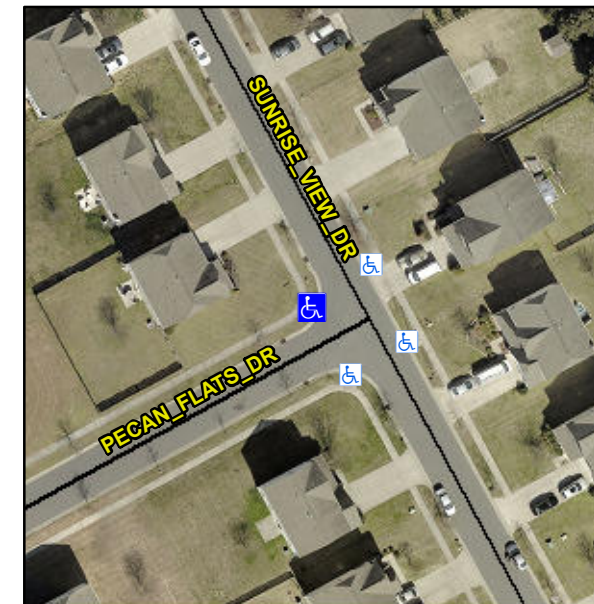
| ADA ID: FE6DE43361CD | Ramp Type: BlendTrans1 | Initial Pass/Fail: Fail | Overall Compliance: No |
| Severity Score: 8.75 | | | |

**Not Found, R304.5.1**

| Compliance | Description | Data | Compliance | Description | Data |
|---|---|---|---|---|---|
| No | Ramp Width (in) | 47.0 | Yes | BlendTrans XSlope (%) | 0.1 |
| | | | No | Curb Slope (%) | 9.6 |

**Remove & Replace Curb Ramp With Two New Directional Ramps or Equivalent.**
