Access Compliance Report

Public Rights-of-Way

(Curb Ramps)

Intersection ID: N/A	Main Street: W_TYVOLA_RD	Cross Street: N/A	Location: E
ADA ID: FE6EBFDA2535	Ramp Type: Perp	Initial Pass/Fail: Fail	Overall Compliance: No
		Severity Score: 10

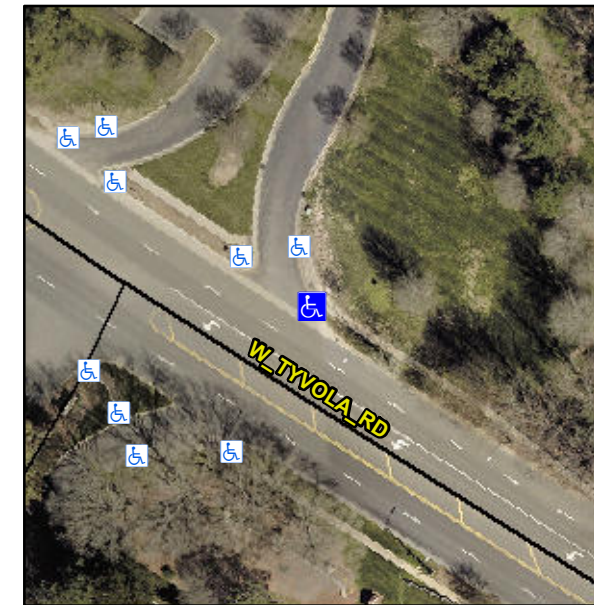
Not Found, R304.5.1

Compliance	Description	Data	Compliance	Description	Data
N/A	Ramp Length (in)	26.0	Yes	Ramp Slope (%)	6.7
No	Ramp Width (in)	43.0	Yes	Ramp XSlope (%)	2.1
N/A	Flare Type LT	N/A	N/A	Flare Type RT	N/A
N/A	Flare Slope LT (%)	N/A	N/A	Flare Slope RT (%)	N/A
N/A	Flare Traversable LT?	No	N/A	Flare Traversable RT?	No
N/A	Landing Length (in)	N/A	N/A	DWS Provided?	N/A
N/A	Landing Width (in)	N/A	N/A	DWS Contrast?	N/A
N/A	Landing Slope (%)	N/A	N/A	DWS Length (in)	N/A
N/A	Landing X Slope (%)	N/A	N/A	DWS Full Width?	N/A
N/A	Landing Curb? (Y/N)	N/A	N/A	DWS Offset (in)	N/A
N/A	Shared Landing?	N/A			
N/A	Gutter Ponding?	N/A	N/A	Gutter Slope (%)	N/A
N/A	Gutter Lip Ht (in)	N/A	N/A	Gutter X Slope (%)	N/A
N/A	Painted X Walk1?	No	N/A	Painted X Walk2?	N/A
	X Walk 1 Direction	To SW		X Walk 2 Direction	N/A
N/A	X Walk 1 Width (in)	N/A	N/A	X Walk 2 Width (in)	N/A
	X Walk 1 Slope (%)	1.9		X Walk 2 Slope (%)	N/A
	X Walk 1 X Slope (%)	2.8		X Walk 2 X Slope (%)	N/A

N/A	Ramp inside XWalk1?	N/A	N/A	Ramp inside XWalk2?	N/A
	Road Slope (%)	N/A	N/A	Clear Space?	N/A
	Road X Slope (%)	N/A	N/A	Clear Space to XWalk (in)	N/A
N/A	Any Obstructions?	N/A	N/A	Storm Grate/Utility Hazard?	N/A
	Obstruction Type			Storm Grate/Utility Type	
		N/A			N/A
			Yes	Surface Condition? (G/P)	Good

Remove & Replace Entire Ramp.

Total Cost: \$ 1850.00
