# Access Compliance Report

## Public Rights-of-Way

### (Curb Ramps)

Intersection ID: 28868	Main Street: BIRDWELL_CT	Cross Street: SUTTONVIEW_DR	Location:	N
ADA ID: FE7834E628D1	Ramp Type: Perp	Initial Pass/Fail: Fail	Overall Compliance: No	Severity Score: 13.75
Codes/Mitigation Info/Possible Solution		Field Measurements/Component Compliance

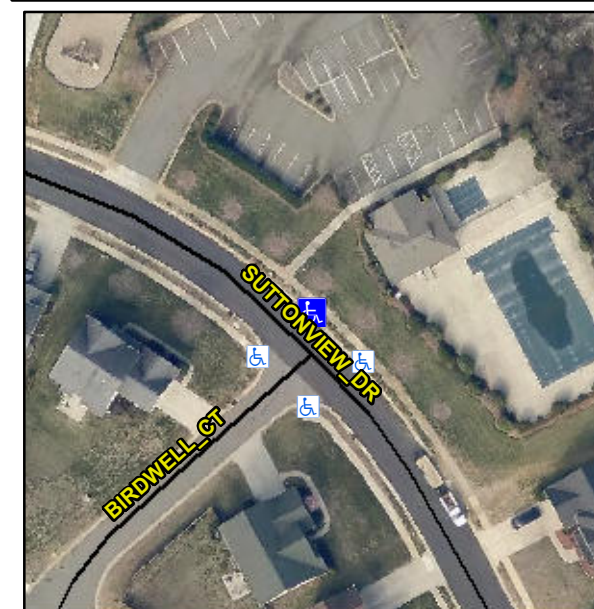
Compliance	Description	Data	Compliance	Description	Data
N/A	Ramp Length (in)	48.0	No	Ramp Slope (%)	10.7
Yes	Ramp Width (in)	52.0	Yes	Ramp XSlope (%)	2.3
N/A	Flare Type LT	N/A	N/A	Flare Type RT	N/A
N/A	Flare Slope LT (%)	N/A	N/A	Flare Slope RT (%)	N/A
N/A	Flare Traversable LT?	N/A	N/A	Flare Traversable RT?	N/A
N/A	Landing Length (in)	N/A	N/A	DWS Provided?	N/A
N/A	Landing Width (in)	N/A	N/A	DWS Contrast?	N/A
N/A	Landing Slope (%)	N/A	N/A	DWS Length (in)	N/A
N/A	Landing X Slope (%)	N/A	N/A	DWS Full Width?	N/A
N/A	Landing Curb? (Y/N)	N/A	N/A	DWS Offset (in)	N/A
N/A	Shared Landing?	N/A			
N/A	Gutter Ponding?	N/A	N/A	Gutter Slope (%)	N/A
N/A	Gutter Lip Ht (in)	N/A	N/A	Gutter X Slope (%)	N/A
N/A	Painted X Walk1?	No	N/A	Painted X Walk2?	N/A
	X Walk 1 Direction	To SW		X Walk 2 Direction	N/A
N/A	X Walk 1 Width (in)	N/A	N/A	X Walk 2 Width (in)	N/A
	X Walk 1 Slope (%)	4.7		X Walk 2 Slope (%)	N/A
	X Walk 1 X Slope (%)	3.9		X Walk 2 X Slope (%)	N/A

N/A	Ramp inside XWalk1?	N/A	N/A	Ramp inside XWalk2?	N/A
	Road Slope (%)	N/A	N/A	Clear Space?	N/A
	Road X Slope (%)	N/A	N/A	Clear Space to XWalk (in)	N/A
N/A	Any Obstructions?	N/A	N/A	Storm Grate/Utility Hazard?	N/A
	Obstruction Type			Storm Grate/Utility Type	
		N/A			N/A
			Yes	Surface Condition? (G/P)	Good

**Remove & Replace Entire Ramp.**

**R304.2.2**

Total Cost: \$ 1850.00
