# Access Compliance Report

## Public Rights-of-Way

### (Curb Ramps)

| Intersection ID: 10042462 | Main Street: YORKMONT_RD | Cross Street: N/A | Location: E |

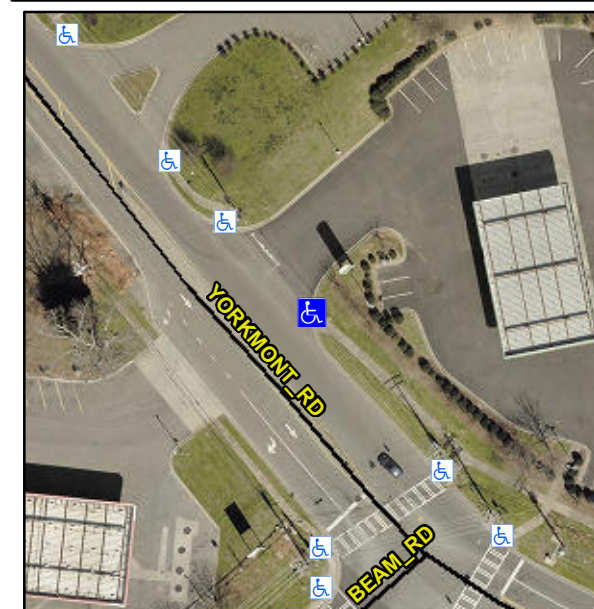
**MEDIAN ACROSS YORKMONT RD**

**R304.5.3, R304.2.3**

| Compliance | Description | Data | Compliance | Description | Data |
|---|---|---|---|---|---|
| Yes | Ramp Width (in) | 48.0 | No | BlendTrans XSlope (%) | 2.2 |
| N/A | Flare Slope LT (%) | N/A | No | Flare Slope RT (%) | N/A |

**Remove & Replace Curb Ramp With Two New Directional Ramps or Equivalent.**

Total Cost: \$ 3200.00

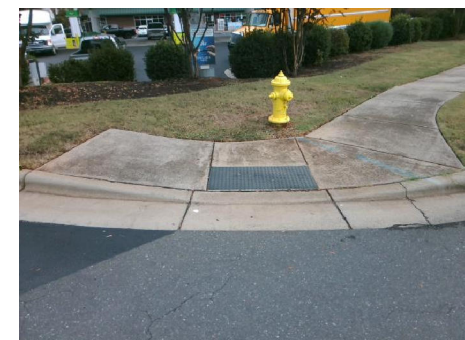
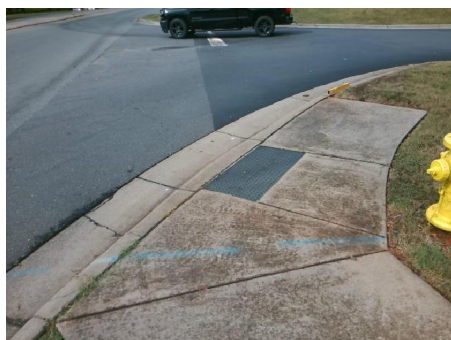
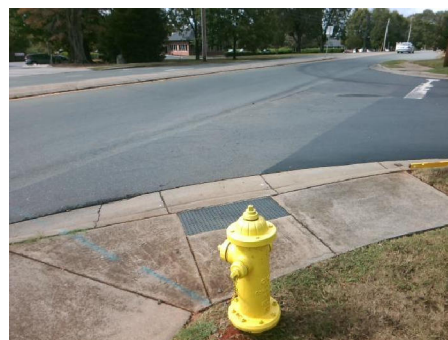
Street 1 Name **ENTRANCE**  
 Stop Condition-Street 1 **StopSign**  
 Street 2 Name **YORKMONT RD**  
 Stop Condition-Street 2 **None**
