Access Compliance Report Public Rights-of-Way (Curb Ramps)

Intersection ID: 31651 Main Street: MAZEN CT Cross Street: WILLIAM REYNOLDS DR Location: SE ADA ID: FE8716F273C3 Ramp Type: Perp Initial Pass/Fail: Fail **Overall Compliance: No** Severity Score: 21.25

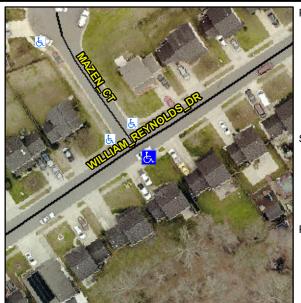
WILLIAM REYNOLDS DR Street 1 Name Stop Condition-Street 2 None N/A Street 2 Name Stop Condition-Street 1 N/A Possible Solutions: Compliance Description N/A Remove & Replace Entire Ramp. No N/A N/A N/A N/A Surveyor Notes: N/A N/A N/A N/A N/A N/A PROW/ADA: Not Found, R304.5.1, R304.2.2
