Access Compliance Report

Public Rights-of-Way

(Curb Ramps)

Intersection ID: 11956	Main Street: E_9TH_ST	Cross Street: N_COLLEGE_ST	Location: E
ADA ID: FE8CC882F575	Ramp Type: PerpDiag	Initial Pass/Fail: Fail	Overall Compliance: No
Severity Score: 8.75			
Codes/Mitigation Info/Possible Solution		Field Measurements/Component Compliance

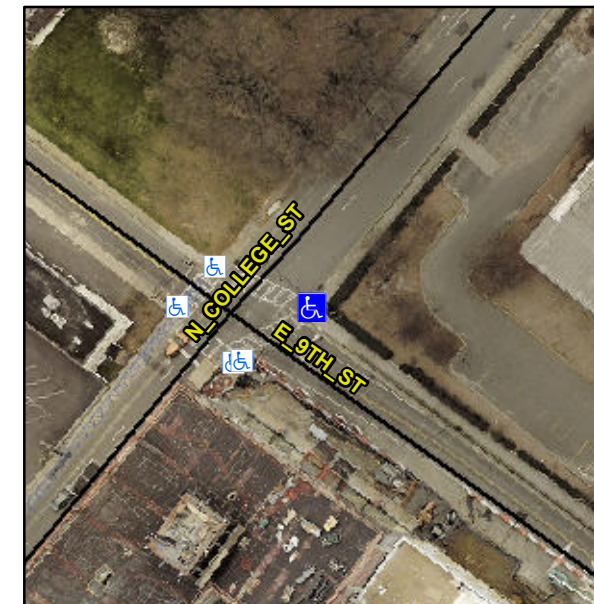
PROW/ADA:

Not Found, R304.5.1

Compliance	Description	Data	Compliance	Description	Data
N/A	Ramp Length (in)	40.0	Yes	Ramp Slope (%)	7.6
No	Ramp Width (in)	47.5	Yes	Ramp XSlope (%)	1.4
N/A	Flare Type LT	N/A	N/A	Flare Type RT	N/A
N/A	Flare Slope LT (%)	N/A	N/A	Flare Slope RT (%)	N/A
N/A	Flare Traversable LT?	N/A	N/A	Flare Traversable RT?	N/A
N/A	Landing Length (in)	N/A	N/A	DWS Provided?	N/A
N/A	Landing Width (in)	N/A	N/A	DWS Contrast?	N/A
N/A	Landing Slope (%)	N/A	N/A	DWS Length (in)	N/A
N/A	Landing X Slope (%)	N/A	N/A	DWS Full Width?	N/A
N/A	Landing Curb? (Y/N)	N/A	N/A	DWS Offset (in)	N/A
N/A	Shared Landing?	N/A			
N/A	Gutter Ponding?	N/A	N/A	Gutter Slope (%)	N/A
N/A	Gutter Lip Ht (in)	1.0	N/A	Gutter X Slope (%)	N/A
N/A	Painted X Walk1?	Yes	N/A	Painted X Walk2?	Yes
	X Walk 1 Direction	To NW		X Walk 2 Direction	To SW
N/A	X Walk 1 Width (in)	95.0	N/A	X Walk 2 Width (in)	95.0
	X Walk 1 Slope (%)	6.7		X Walk 2 Slope (%)	3.4
	X Walk 1 X Slope (%)	0.7		X Walk 2 X Slope (%)	7.8

N/A	Ramp inside XWalk1?	Yes	N/A	Ramp inside XWalk2?	Yes
	Road Slope (%)	0.4	N/A	Clear Space?	N/A
	Road X Slope (%)	6.7	N/A	Clear Space to XWalk (in)	N/A
N/A	Any Obstructions?	N/A	N/A	Storm Grate/Utility Hazard?	N/A
	Obstruction Type			Storm Grate/Utility Type	
		N/A			N/A
		Yes		Surface Condition? (G/P)	Good

Possible Solutions:

Remove & Replace Curb Ramp With Two New Directional Ramps or Equivalent.
