Access Compliance Report

Public Rights-of-Way

(Curb Ramps)

Intersection ID: 15181	Main Street: BRIARFIELD_DR	Cross Street: KIMWOOD_PL	Location: NE
ADA ID: FE98F609E2FC	Ramp Type: PerpDiag	Initial Pass/Fail: Fail	Overall Compliance: No
Severity Score: 12.5			
Codes/Mitigation Info/Possible Solution		Field Measurements/Component Compliance

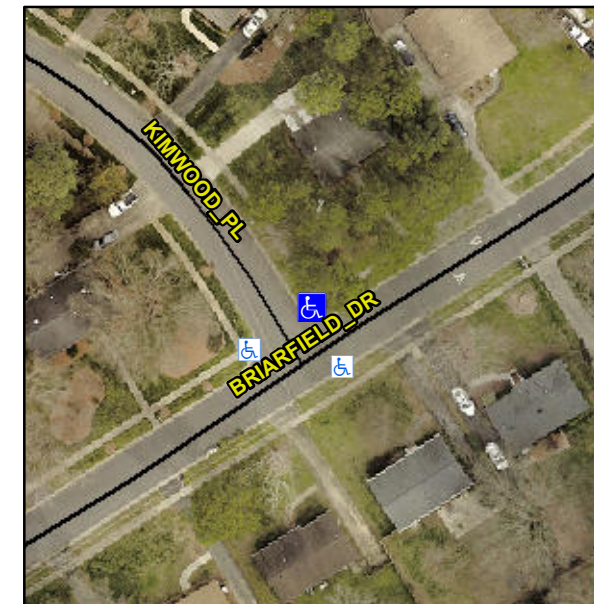
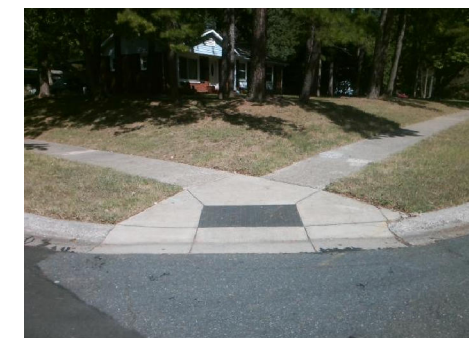
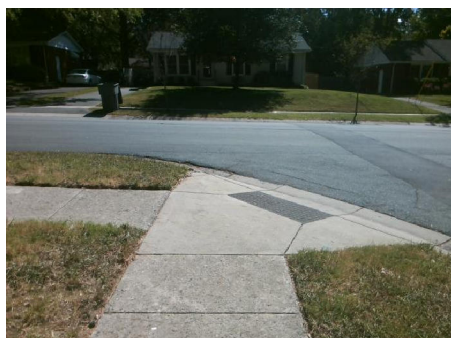
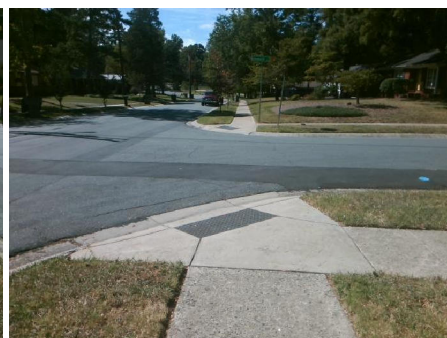
Not Found, R304.2.2

Compliance	Description	Data	Compliance	Description	Data
N/A	Ramp Length (in)	50.0	No	Ramp Slope (%)	11.7
Yes	Ramp Width (in)	48.0	Yes	Ramp XSlope (%)	1.9
N/A	Flare Type LT	N/A	N/A	Flare Type RT	N/A
N/A	Flare Slope LT (%)	N/A	N/A	Flare Slope RT (%)	N/A
N/A	Flare Traversable LT?	N/A	N/A	Flare Traversable RT?	N/A
N/A	Landing Length (in)	N/A	N/A	DWS Provided?	N/A
N/A	Landing Width (in)	N/A	N/A	DWS Contrast?	N/A
N/A	Landing Slope (%)	N/A	N/A	DWS Length (in)	N/A
N/A	Landing X Slope (%)	N/A	N/A	DWS Full Width?	N/A
N/A	Landing Curb? (Y/N)	N/A	N/A	DWS Offset (in)	N/A
N/A	Shared Landing?	N/A			
N/A	Gutter Ponding?	N/A	N/A	Gutter Slope (%)	N/A
N/A	Gutter Lip Ht (in)	N/A	N/A	Gutter X Slope (%)	N/A
N/A	Painted X Walk1?	No	N/A	Painted X Walk2?	No
	X Walk 1 Direction	To SW		X Walk 2 Direction	To S
N/A	X Walk 1 Width (in)	N/A	N/A	X Walk 2 Width (in)	N/A
	X Walk 1 Slope (%)	1.4		X Walk 2 Slope (%)	2.2
	X Walk 1 X Slope (%)	2.3		X Walk 2 X Slope (%)	2.3

N/A	Ramp inside XWalk1?	N/A	N/A	Ramp inside XWalk2?	N/A
	Road Slope (%)	3.3	N/A	Clear Space?	N/A
	Road X Slope (%)	1.3	N/A	Clear Space to XWalk (in)	N/A
N/A	Any Obstructions?	N/A	N/A	Storm Grate/Utility Hazard?	N/A
	Obstruction Type			Storm Grate/Utility Type	
		N/A			N/A
		Yes		Surface Condition? (G/P)	Good

Remove & Replace Curb Ramp With Two New Directional Ramps or Equivalent.
