# Access Compliance Report

## Public Rights-of-Way

### (Curb Ramps)

Intersection ID: 42513	Main Street: ELM_LN	Cross Street: INDIGO_RW	Location: W
ADA ID: FEA9B2133068	Ramp Type: Perp	Initial Pass/Fail: Fail	Overall Compliance: No
Severity Score: 12.5			
Codes/Mitigation Info/Possible Solution		Field Measurements/Component Compliance

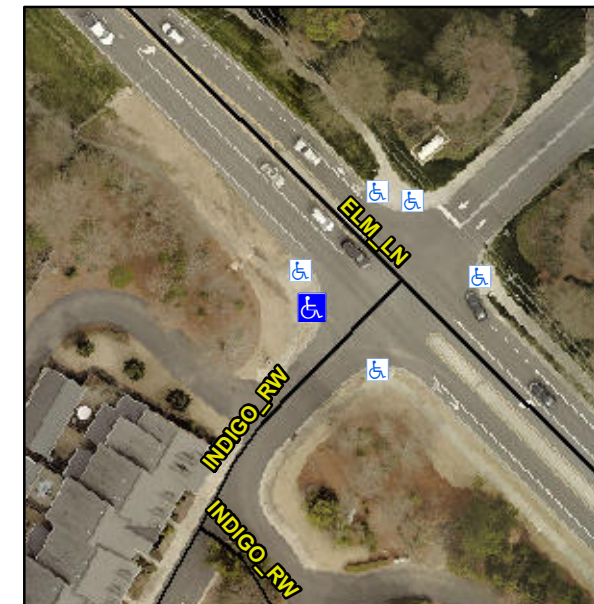
**Not Found, R304.2.2**

Compliance	Description	Data	Compliance	Description	Data
N/A	Ramp Length (in)	106.0	No	Ramp Slope (%)	9.7
Yes	Ramp Width (in)	48.0	Yes	Ramp XSlope (%)	0.6
N/A	Flare Type LT	N/A	N/A	Flare Type RT	N/A
N/A	Flare Slope LT (%)	N/A	N/A	Flare Slope RT (%)	N/A
N/A	Flare Traversable LT?	N/A	N/A	Flare Traversable RT?	N/A
N/A	Landing Length (in)	N/A	N/A	DWS Provided?	N/A
N/A	Landing Width (in)	N/A	N/A	DWS Contrast?	N/A
N/A	Landing Slope (%)	N/A	N/A	DWS Length (in)	N/A
N/A	Landing X Slope (%)	N/A	N/A	DWS Full Width?	N/A
N/A	Landing Curb? (Y/N)	N/A	N/A	DWS Offset (in)	N/A
N/A	Shared Landing?	N/A			
N/A	Gutter Ponding?	N/A	N/A	Gutter Slope (%)	N/A
N/A	Gutter Lip Ht (in)	N/A	N/A	Gutter X Slope (%)	N/A
N/A	Painted X Walk1?	No	N/A	Painted X Walk2?	N/A
	X Walk 1 Direction	To SE		X Walk 2 Direction	N/A
N/A	X Walk 1 Width (in)	N/A	N/A	X Walk 2 Width (in)	N/A
	X Walk 1 Slope (%)	2.3		X Walk 2 Slope (%)	N/A
	X Walk 1 X Slope (%)	1.9		X Walk 2 X Slope (%)	N/A

**Remove & Replace Entire Ramp.**
