Access Compliance Report

Public Rights-of-Way

(Curb Ramps)

Intersection ID: 11201	Main Street: BRIARHILL_DR	Cross Street: MEADOWCLIFF_DR	Location: SE
ADA ID: FEAD075608CE	Ramp Type: Directional1	Initial Pass/Fail: Pass	Overall Compliance: No
Severity Score: 0			
Codes/Mitigation Info/Possible Solution		Field Measurements/Component Compliance

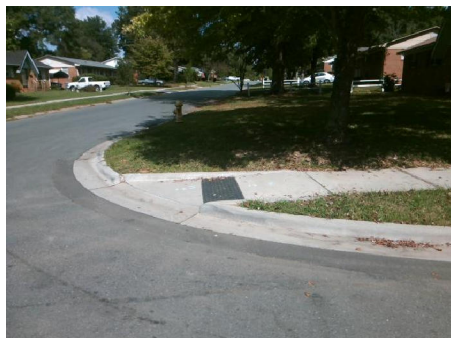
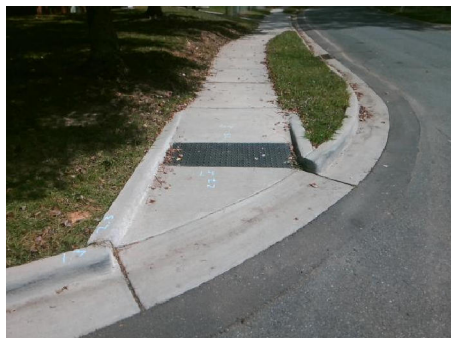
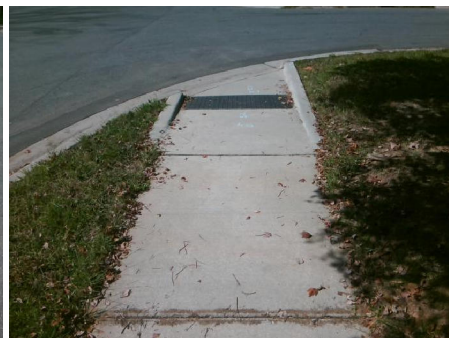
Compliance	Description	Data	Compliance	Description	Data
N/A	Ramp Length (in)	51.0	Yes	Grade Break?	Yes
Yes	Ramp Width (in)	58.5	Yes	Grade Break Slope (%)	2.7
Yes	Ramp Slope (%)	5.2	Yes	Grade Break XSlope (%)	1.4
Yes	Ramp XSlope (%)	0.4			
Yes	Flare Type LT	N/A	Yes	Flare Type RT	N/A
N/A	Flare Slope LT (%)	N/A	N/A	Flare Slope RT (%)	N/A
N/A	Flare Traversable LT?	No	N/A	Flare Traversable RT?	No
Yes	Landing Length (in)	68.0	Yes	DWS Provided?	Yes
Yes	Landing Width (in)	60.0	Yes	DWS Contrast?	Yes
Yes	Landing Slope (%)	0.2	Yes	DWS Length (in)	24.0
Yes	Landing X Slope (%)	1.8	Yes	DWS Full Width?	Yes
N/A	Landing Curb? (Y/N)	N/A	Yes	DWS Offset LT (in)	52.5
N/A	Shared Landing?	No	Yes	DWS Offset RT (in)	0.0
Yes	Gutter Ponding?	No	Yes	Gutter Slope (%)	1.0
Yes	Gutter Lip Ht (in)	0.0	Yes	Gutter X Slope (%)	0.1
N/A	Painted X Walk1?	No		Road Slope (%)	2.3
	X Walk 1 Direction	To NW		Road X Slope (%)	1.3
	X Walk 1 Width (in)	N/A		Clear Space?	Yes

X Walk 1 Slope (%)	2.3	N/A	Clear Space to XWalk (in)	N/A
	X Walk 1 X Slope (%)	1.3	Yes	Storm Grate/Utility Hazard?	No
N/A	Ramp inside XWalk1?	N/A		Storm Grate/Utility Type	
Yes	Any Obstructions?	No			N/A
	Obstruction Type		Yes	Surface Condition? (G/P)	Good
			N/A	Curb Slope (%)	18.0

Possible Solutions:

Remove & Replace Entire Ramp.
