# Access Compliance Report

## Public Rights-of-Way

### (Curb Ramps)

Intersection ID: 15632	Main Street: EXECUTIVE_CENTER_DR	Cross Street: FARM_POND_LN	Location: SW
ADA ID: FEB73F83D2F4	Ramp Type: BlendTrans2	Initial Pass/Fail: Fail	Overall Compliance: No
		Severity Score: 10

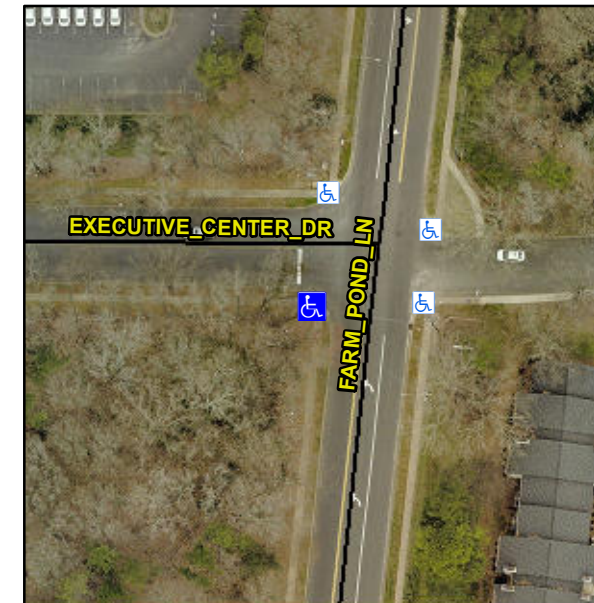
Compliance	Description	Data	Compliance	Description	Data
N/A	Ramp Length (in)	62.0	Yes	BlendTrans Slope (%)	1.9
No	Ramp Width (in)	47.0	No	BlendTrans XSlope (%)	2.4
N/A	Flare Type LT	N/A	N/A	Flare Type RT	N/A
N/A	Flare Slope LT (%)	N/A	N/A	Flare Slope RT (%)	N/A
N/A	Flare Traversable LT?	N/A	N/A	Flare Traversable RT?	N/A
N/A	Landing Length (in)	N/A	N/A	DWS Provided?	N/A
N/A	Landing Width (in)	N/A	N/A	DWS Contrast?	N/A
N/A	Landing Slope (%)	N/A	N/A	DWS Length (in)	N/A
N/A	Landing X Slope (%)	N/A	N/A	DWS Full Width?	N/A
N/A	Landing Curb? (Y/N)	N/A	N/A	DWS Offset (in)	N/A
N/A	Shared Landing?	N/A			
N/A	Gutter Ponding?	N/A	N/A	Gutter Slope (%)	N/A
N/A	Gutter Lip Ht (in)	N/A	N/A	Gutter X Slope (%)	N/A
N/A	Painted X Walk1?	No	N/A	Painted X Walk2?	No
	X Walk 1 Direction	To E		X Walk 2 Direction	To N
	X Walk 1 Width (in)	N/A		X Walk 2 Width (in)	N/A
	X Walk 1 Slope (%)	4.5		X Walk 2 Slope (%)	1.1
	X Walk 1 X Slope (%)	0.2		X Walk 2 X Slope (%)	3.9

N/A	Ramp inside XWalk1?	N/A	N/A	Ramp inside XWalk2?	N/A
	Road Slope (%)	2.6		Clear Space?	N/A
	Road X Slope (%)	3.8	N/A	Clear Space to XWalk (in)	N/A
N/A	Any Obstructions?	N/A	N/A	Storm Grate/Utility Hazard?	N/A
	Obstruction Type			Storm Grate/Utility Type	
		N/A			N/A
			Yes	Surface Condition? (G/P)	Good
			No	Curb Slope (%)	12.5

**Remove & Replace Curb Ramp With Two New Directional Ramps or Equivalent.**
