Access Compliance Report

Public Rights-of-Way

(Curb Ramps)

Intersection ID: 6555	Main Street: UNIVERSITY_CITY_BV	Cross Street: SANCTUARY_PL	Location: NE
ADA ID: FEC4D4777366	Ramp Type: Perp	Initial Pass/Fail: Fail	Overall Compliance: No
Codes/Mitigation Info/Possible Solution		Field Measurements/Component Compliance	
Severity Score: 22.5

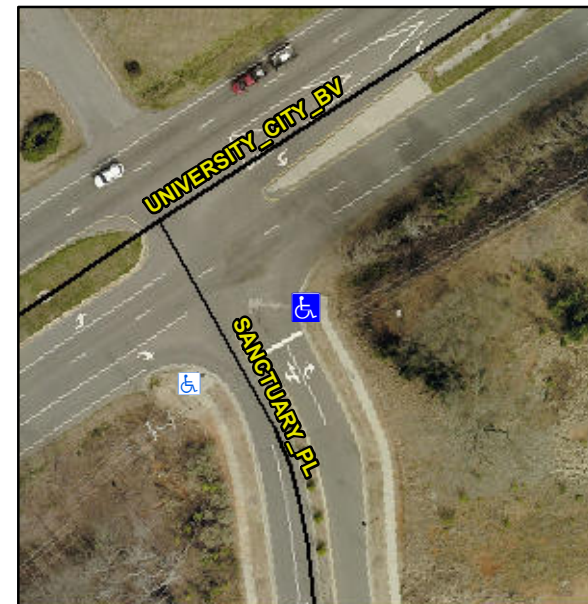
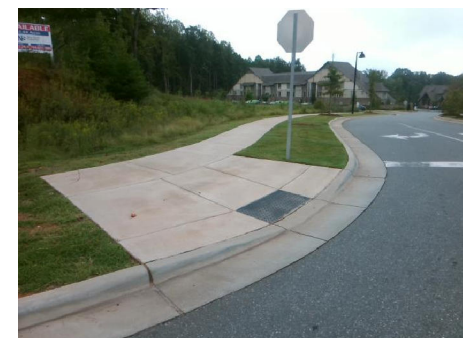
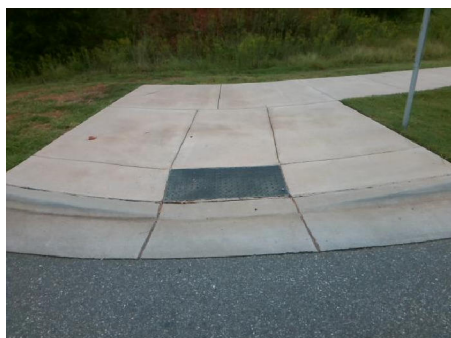
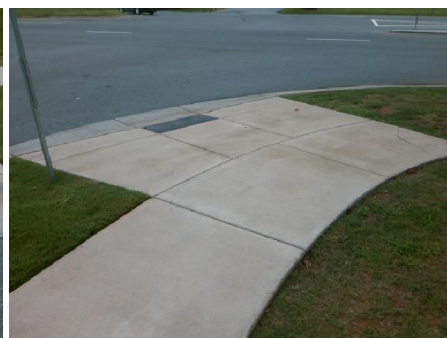
Not Found, R304.5.1, R304.2.2, R304.5.3

Compliance	Description	Data	Compliance	Description	Data
N/A	Ramp Length (in)	96.0	No	Ramp Slope (%)	9.2
No	Ramp Width (in)	43.0	No	Ramp XSlope (%)	2.3
N/A	Flare Type LT	N/A	N/A	Flare Type RT	N/A
N/A	Flare Slope LT (%)	N/A	N/A	Flare Slope RT (%)	N/A
N/A	Flare Traversable LT?	N/A	N/A	Flare Traversable RT?	N/A
N/A	Landing Length (in)	N/A	N/A	DWS Provided?	N/A
N/A	Landing Width (in)	N/A	N/A	DWS Contrast?	N/A
N/A	Landing Slope (%)	N/A	N/A	DWS Length (in)	N/A
N/A	Landing X Slope (%)	N/A	N/A	DWS Full Width?	N/A
N/A	Landing Curb? (Y/N)	N/A	N/A	DWS Offset (in)	N/A
N/A	Shared Landing?	N/A			
N/A	Gutter Ponding?	N/A	N/A	Gutter Slope (%)	N/A
N/A	Gutter Lip Ht (in)	N/A	N/A	Gutter X Slope (%)	N/A
N/A	Painted X Walk1?	No	N/A	Painted X Walk2?	N/A
	X Walk 1 Direction	To W		X Walk 2 Direction	N/A
N/A	X Walk 1 Width (in)	N/A	N/A	X Walk 2 Width (in)	N/A
	X Walk 1 Slope (%)	2.7		X Walk 2 Slope (%)	N/A
	X Walk 1 X Slope (%)	0.5		X Walk 2 X Slope (%)	N/A

N/A	Ramp inside XWalk1?	N/A	N/A	Ramp inside XWalk2?	N/A
	Road Slope (%)	N/A	N/A	Clear Space?	N/A
	Road X Slope (%)	N/A	N/A	Clear Space to XWalk (in)	N/A
N/A	Any Obstructions?	N/A	N/A	Storm Grate/Utility Hazard?	N/A
	Obstruction Type			Storm Grate/Utility Type	
		N/A			N/A
			Yes	Surface Condition? (G/P)	Good

Remove & Replace Entire Ramp.
