## **Access Compliance Report Public Rights-of-Way** (Curb Ramps)

Intersection ID: 26275 Main Street: PARK RD **Cross Street: TRADEWINDS LN** Location: SW **Overall Compliance: No Severity Score: ADA ID: FEC61BDDA432** Ramp Type: PerpDiag Initial Pass/Fail: Fail 8.75

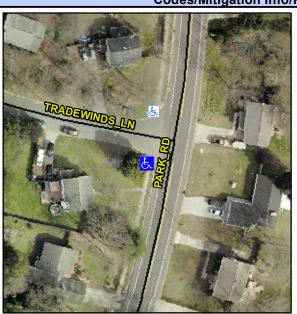
Yes Ramp XSlope (%) Ramp Width (in) 45.0 1.8 N/A Flare Type LT N/A Flare Type RT N/A N/A N/A Flare Slope RT (%) N/A Flare Slope LT (%) Flare Traversable LT? N/A N/A Flare Traversable RT? N/A N/A N/A **DWS Provided?** N/A Landing Length (in) Landing Width (in) N/A N/A **DWS Contrast?** N/A N/A Landing Slope (%) N/A DWS Length (in) N/A Landing X Slope (%) N/A N/A DWS Full Width? N/A Landing Curb? (Y/N) N/A N/A DWS Offset (in) N/A N/A Shared Landing? **Gutter Ponding?** N/A N/A Gutter Slope (%) N/A Gutter Lip Ht (in) N/A N/A Gutter X Slope (%) N/A Painted X Walk1? No N/A Painted X Walk2? No X Walk 1 Direction To E X Walk 2 Direction To N N/A X Walk 1 Width (in) X Walk 2 Width (in) N/A X Walk 1 Slope (%) 2.3 X Walk 2 Slope (%) 1.7 X Walk 2 X Slope (%) X Walk 1 X Slope (%) 3.2 2.6 N/A N/A Ramp inside XWalk2? N/A Ramp inside XWalk1? Road Slope (%) 0.4 N/A Clear Space? N/A N/A Road X Slope (%) 3.0 Clear Space to XWalk (in) N/A N/A Any Obstructions? N/A Storm Grate/Utility Hazard? N/A **Obstruction Type** Storm Grate/Utility Type N/A N/A Yes Surface Condition? (G/P) Good

Compliance Description Possible Solutions: N/A Remove & Replace Curb Ramp With Two New Directional Ramps or Equivalent. Surveyor Notes: N/A PROW/ADA: Not Found, R304.5.1
