# Access Compliance Report

## Public Rights-of-Way

### (Curb Ramps)

Intersection ID: 27384	Main Street: DOVEHUNT_PL	Cross Street: VALLEY_SPRING_DR	Location: W
ADA ID: FECC5B94990E	Ramp Type: PerpDiag	Initial Pass/Fail: Fail	Overall Compliance: No
Severity Score: 25			
Codes/Mitigation Info/Possible Solution		Field Measurements/Component Compliance

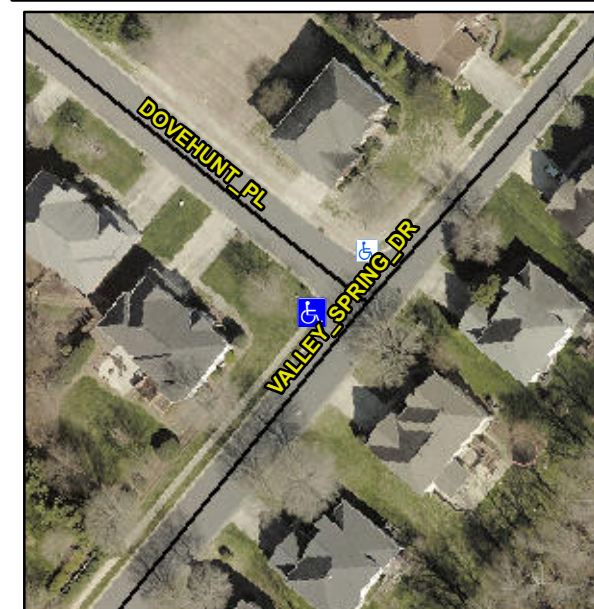
**Not Found, R304.2.2, R304.5.3**

Compliance	Description	Data	Compliance	Description	Data
N/A	Ramp Length (in)	47.0	No	Ramp Slope (%)	9.1
Yes	Ramp Width (in)	48.0	No	Ramp XSlope (%)	5.5
N/A	Flare Type LT	N/A	N/A	Flare Type RT	N/A
N/A	Flare Slope LT (%)	N/A	N/A	Flare Slope RT (%)	N/A
N/A	Flare Traversable LT?	N/A	N/A	Flare Traversable RT?	N/A
N/A	Landing Length (in)	N/A	N/A	DWS Provided?	N/A
N/A	Landing Width (in)	N/A	N/A	DWS Contrast?	N/A
N/A	Landing Slope (%)	N/A	N/A	DWS Length (in)	N/A
N/A	Landing X Slope (%)	N/A	N/A	DWS Full Width?	N/A
N/A	Landing Curb? (Y/N)	N/A	N/A	DWS Offset (in)	N/A
N/A	Shared Landing?	N/A			
N/A	Gutter Ponding?	N/A	N/A	Gutter Slope (%)	N/A
N/A	Gutter Lip Ht (in)	N/A	N/A	Gutter X Slope (%)	N/A
N/A	Painted X Walk1?	No	N/A	Painted X Walk2?	No
	X Walk 1 Direction	To SE		X Walk 2 Direction	To NE
N/A	X Walk 1 Width (in)	N/A	N/A	X Walk 2 Width (in)	N/A
	X Walk 1 Slope (%)	0.6		X Walk 2 Slope (%)	7.2
	X Walk 1 X Slope (%)	8.1		X Walk 2 X Slope (%)	0.4

N/A	Ramp inside XWalk1?	N/A	N/A	Ramp inside XWalk2?	N/A
	Road Slope (%)	4.2	N/A	Clear Space?	N/A
	Road X Slope (%)	6.1	N/A	Clear Space to XWalk (in)	N/A
N/A	Any Obstructions?	N/A	N/A	Storm Grate/Utility Hazard?	N/A
	Obstruction Type			Storm Grate/Utility Type	
		N/A			N/A
			Yes	Surface Condition? (G/P)	Good

Possible Solutions:

**Remove & Replace Curb Ramp With Two New Directional Ramps or Equivalent.**
