# Access Compliance Report

## Public Rights-of-Way

### (Curb Ramps)

Intersection ID: 10025502	Main Street: E_MOREHEAD_ST	Cross Street: N/A	Location: SW
ADA ID: FECD623FF3C9	Ramp Type: BlendTrans1	Initial Pass/Fail: Fail	Overall Compliance: No
		Severity Score: 8.75

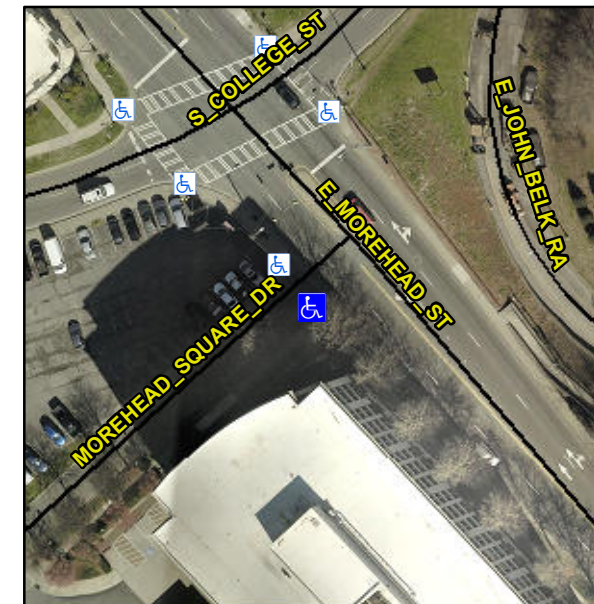
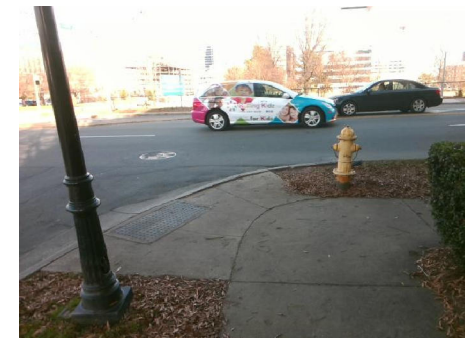
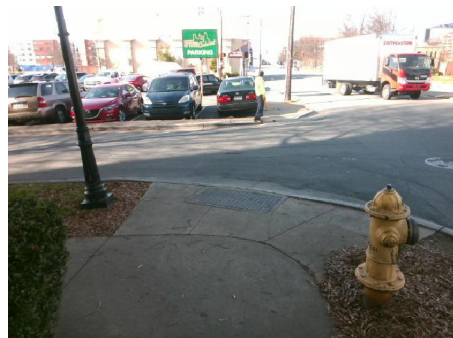
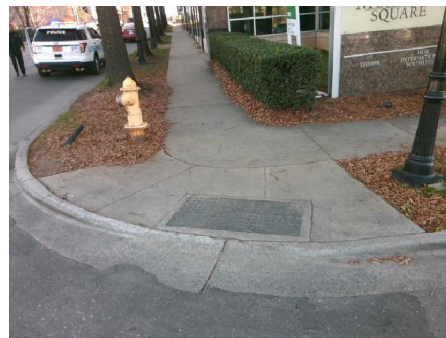
**Not Found, R304.5.1**

Compliance	Description	Data	Compliance	Description	Data
N/A	Ramp Length (in)	63.0	Yes	BlendTrans Slope (%)	2.7
No	Ramp Width (in)	36.0	Yes	BlendTrans XSlope (%)	0.7
N/A	Flare Type LT	N/A	N/A	Flare Type RT	N/A
N/A	Flare Slope LT (%)	N/A	N/A	Flare Slope RT (%)	N/A
N/A	Flare Traversable LT?	N/A	N/A	Flare Traversable RT?	N/A
N/A	Landing Length (in)	N/A	N/A	DWS Provided?	N/A
N/A	Landing Width (in)	N/A	N/A	DWS Contrast?	N/A
N/A	Landing Slope (%)	N/A	N/A	DWS Length (in)	N/A
N/A	Landing X Slope (%)	N/A	N/A	DWS Full Width?	N/A
N/A	Landing Curb? (Y/N)	N/A	N/A	DWS Offset (in)	N/A
N/A	Shared Landing?	N/A			
N/A	Gutter Ponding?	N/A	N/A	Gutter Slope (%)	N/A
N/A	Gutter Lip Ht (in)	N/A	N/A	Gutter X Slope (%)	N/A
N/A	Painted X Walk1?	No	N/A	Painted X Walk2?	No
	X Walk 1 Direction	To NE		X Walk 2 Direction	To NW
	X Walk 1 Width (in)	N/A		X Walk 2 Width (in)	N/A
	X Walk 1 Slope (%)	0.3		X Walk 2 Slope (%)	1.2
	X Walk 1 X Slope (%)	1.3		X Walk 2 X Slope (%)	2.5

N/A	Ramp inside XWalk1?	N/A	N/A	Ramp inside XWalk2?	N/A
	Road Slope (%)	2.7		Clear Space?	N/A
	Road X Slope (%)	3.0	N/A	Clear Space to XWalk (in)	N/A
N/A	Any Obstructions?	N/A	N/A	Storm Grate/Utility Hazard?	N/A
	Obstruction Type			Storm Grate/Utility Type	
		N/A			N/A
			Yes	Surface Condition? (G/P)	Good
			No	Curb Slope (%)	22.3

**Remove & Replace Curb Ramp With Two New Directional Ramps or Equivalent.**

Total Cost: \$ 3200.00
