Access Compliance Report

Public Rights-of-Way (Curb Ramps)

Intersection ID: 46493	Main Street: TRAILWATER_RD	Cross Street: BERE_ISLAND_DR	Location: SE
ADA ID: FED97EC4270C	Ramp Type: Perp	Initial Pass/Fail: Fail	Overall Compliance: No
		Severity Score: 8.75

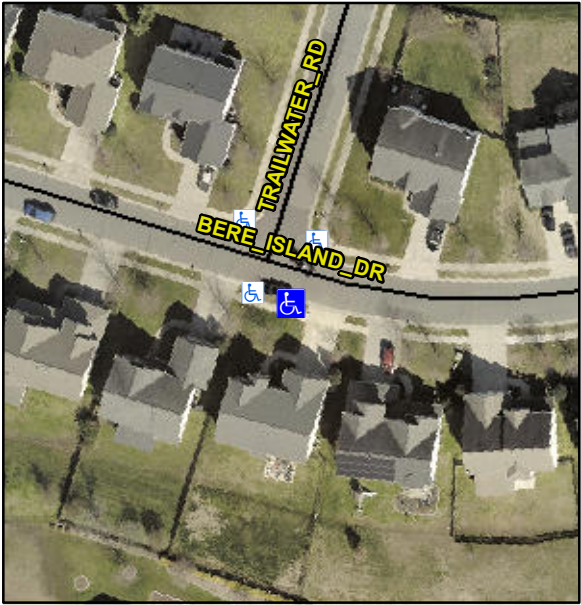
Possible Solutions:		Compliance	Description	Data	
	Remove & Replace Entire Ramp.		N/A	Ramp Length (in)	48.0	Yes
			No	Ramp Width (in)	46.5	Yes
			N/A	Flare Type LT	N/A	N/A
			N/A	Flare Slope LT (%)	N/A	N/A
			N/A	Flare Traversable LT?	N/A	N/A
			N/A	Landing Length (in)	N/A	N/A
			N/A	Landing Width (in)	N/A	N/A
			N/A	Landing Slope (%)	N/A	N/A
			N/A	Landing X Slope (%)	N/A	N/A
			N/A	Landing Curb? (Y/N)	N/A	N/A
			N/A	Shared Landing?	N/A	
			N/A	Gutter Ponding?	N/A	N/A
			N/A	Gutter Lip Ht (in)	N/A	N/A
			N/A	Painted X Walk1?	No	N/A
				X Walk 1 Direction	To NE	N/A
			N/A	X Walk 1 Width (in)	N/A	N/A
				X Walk 1 Slope (%)	3.1	N/A
				X Walk 1 X Slope (%)	1.2	N/A
			N/A	Ramp inside XWalk1?	N/A	N/A
<p>Surveyor Notes:</p> <p>N/A</p> <p>PROW/ADA:</p> <p>Not Found, R304.5.1</p>			N/A	Road Slope (%)	N/A	N/A
			N/A	Road X Slope (%)	N/A	N/A

N/A	Any Obstructions?	N/A	N/A
				Obstruction Type		
					N/A	N/A
			Yes	Surface Condition? (G/P)	Good	
Total Cost:		\$ 1850.00

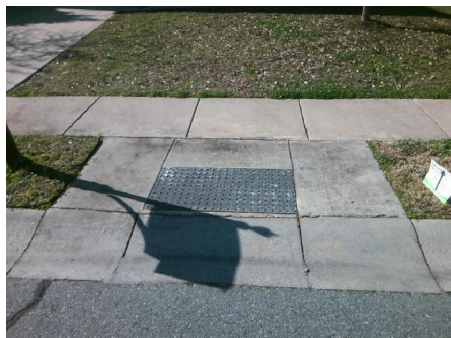
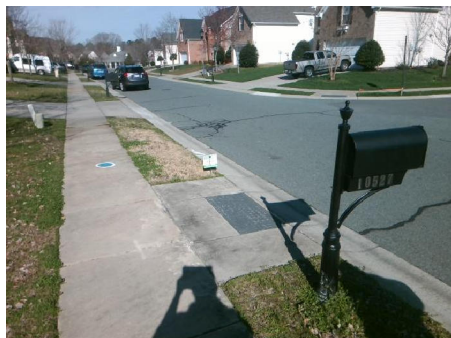
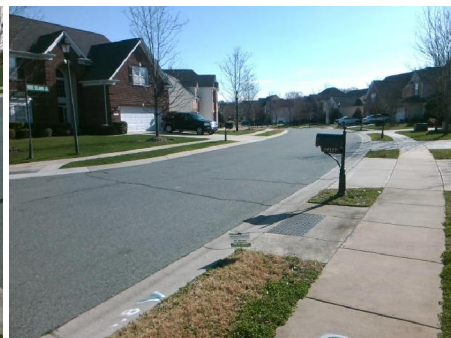
Street 1 Name	BRE ISLAND DR
Stop Condition-Street 2	None
Street 2 Name	N/A
Stop Condition-Street 1	N/A
