# Access Compliance Report

## Public Rights-of-Way

### (Curb Ramps)

Intersection ID: 5924	Main Street: GUM_BRANCH_RD	Cross Street: WOODLYNN_DR	Location: NE
ADA ID: FEDBB375D2C7	Ramp Type: Combination1	Initial Pass/Fail: Fail	Overall Compliance: No
			Severity Score: 13.75

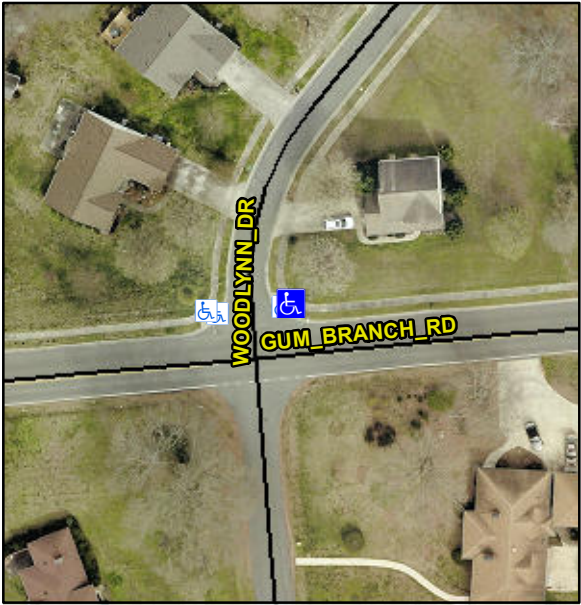
Possible Solutions:		<b>Compliance</b>	<b>Description</b>	<b>Data</b>
	Remove & Replace Entire Ramp.		N/A	Ramp Length LT (in)	31.0
			Yes	Ramp Width LT (in)	68.0
			Yes	Ramp Slope LT (%)	4.1
			No	Ramp XSlope LT (%)	2.9
			N/A	Ramp Length (in)	31.0
			Yes	Ramp Width (in)	48.0
	Surveyor Notes:		N/A	Flare Type LT	N/A
	RP & LT RP < 5%		N/A	Flare Slope LT (%)	N/A
			N/A	Flare Traversable LT?	N/A
<p>PROW/ADA:</p> <p><b>R304.5.3, R304.3.2</b></p>			N/A	Landing Length (in)	N/A
			N/A	Landing Width (in)	N/A
			N/A	Landing Slope (%)	N/A
			N/A	Landing X Slope (%)	N/A
			N/A	Landing Curb? (Y/N)	N/A
			N/A	Shared Landing?	N/A
			N/A	Gutter Ponding?	N/A
			N/A	Gutter Lip Ht (in)	N/A
			N/A	Painted X Walk1?	No
				X Walk 1 Direction	To W
<p>Street 1 Name</p> <p>Stop Condition-Street 1</p> <p>Street 2 Name</p> <p>Stop Condition-Street 2</p>			N/A	X Walk 1 Width (in)	N/A

X Walk 1 Slope (%)	0.8
				X Walk 1 X Slope (%)	3.9
	Total Cost:	\$ 1800.00	N/A	Ramp inside XWalk1?	N/A
				Road Slope (%)	N/A
				Road X Slope (%)	N/A
				Clear Space?	N/A
				Clear Space to XWalk (in)	N/A
				Any Obstruction?	N/A
				Obstruction Type	N/A
