## Access Compliance Report Public Rights-of-Way (Curb Ramps)

Intersection ID: 46668Main Street: PICASSO\_CTCross Street: CARD\_STLocation:SWADA ID: FEE189EF8F02Ramp Type: BlendTrans2Initial Pass/Fail: PassOverall Compliance: NoSeverity Score:10

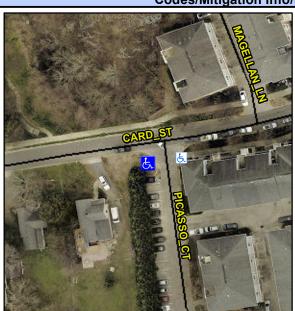
N/
N/
N/
Surveyor Notes:
NO CURB

Comp	liance Description	Data	Comp	oliance	Description	Data
N/A	Ramp Length (in)	84.0	Yes	Blend	Trans Slope (%)	1.7
Yes	Ramp Width (in)	72.0	Yes	Blend	Trans XSlope (%)	2.0
N/A	Flare Type LT	None	N/A	Flare	Type RT	None
N/A	Flare Slope LT (%)	N/A	N/A	Flare	Slope RT (%)	N/A
N/A	Flare Traversable LT?	N/A	N/A	Flare	Traversable RT?	N/A
N/A	Landing Length (in)	N/A	No	DWS	Provided?	No
N/A	Landing Width (in)	N/A	N/A	DWS	Contrast?	No
N/A	Landing Slope (%)	N/A	N/A	DWS	Length (in)	N/A
N/A	Landing X Slope (%)	N/A	N/A	DWS	Full Width?	No
N/A	Landing Curb? (Y/N)	No	N/A	DWS	Offset (in)	N/A
N/A	Shared Landing?	No				
Yes	Gutter Ponding?	No	Yes	Gutte	r Slope (%)	1.4
Yes	Gutter Lip Ht (in)	0.0	No	Gutte	r X Slope (%)	2.2
N/A	Painted X Walk1?	No	N/A	Painte	ed X Walk2?	N/A
	X Walk 1 Direction	То Е		X Wa	lk 2 Direction	N/A
	X Walk 1 Width (in)	N/A		X Wa	lk 2 Width (in)	N/A
	X Walk 1 Slope (%)	2.0		X Wa	lk 2 Slope (%)	N/A
	X Walk 1 X Slope (%)	1.9		X Wa	lk 2 X Slope (%)	N/A

N/A	Ramp inside XWalk1?	N/A	N/A	Ramp	inside XWalk2?	N/A
	Road Slope (%)	1.9		Clear	Space?	Yes
	Road X Slope (%)	2.0	N/A	Clear	Space to XWalk (in)	N/A
Yes	Any Obstructions?	No	Yes	Storm	Grate/Utility Hazard?	No
	Obstruction Type			Storm	Grate/Utility Type	
		N/A				N/A
			Yes	Surfa	ce Condition? (G/P)	Good
			N/A	Curb	Slope (%)	N/A

Possible Solutions:

Install Detectable Warning System.

Remove & Replace Gutter.

N/
PROW/ADA:
R305, R304.5.3
