Access Compliance Report

Public Rights-of-Way

(Curb Ramps)

Intersection ID: 26040	Main Street: NORTH_COURSE_DR	Cross Street: ROUNDING_RUN_RD	Location: SW
ADA ID: FEE52573E569	Ramp Type: PerpDiag	Initial Pass/Fail: Fail	Overall Compliance: No
Severity Score: 10			
Codes/Mitigation Info/Possible Solution		Field Measurements/Component Compliance

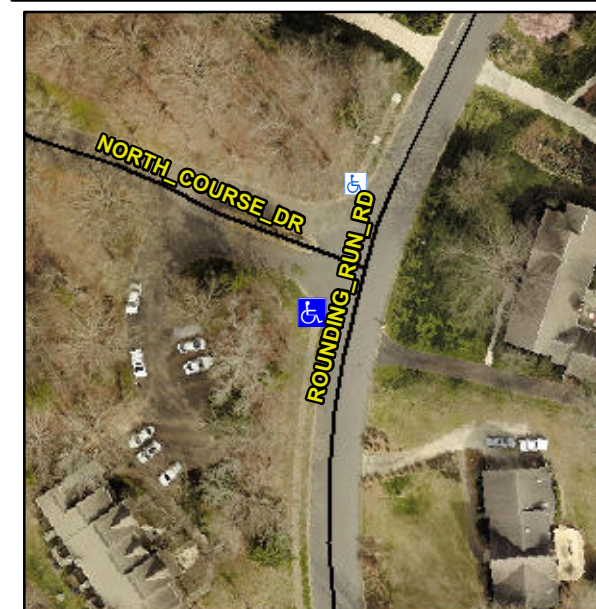
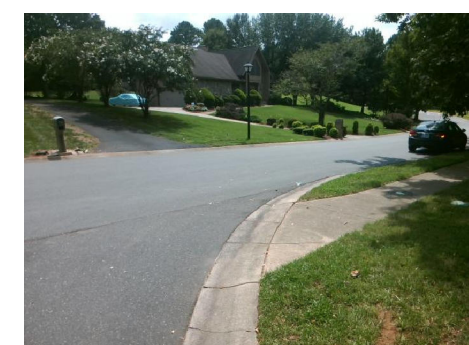
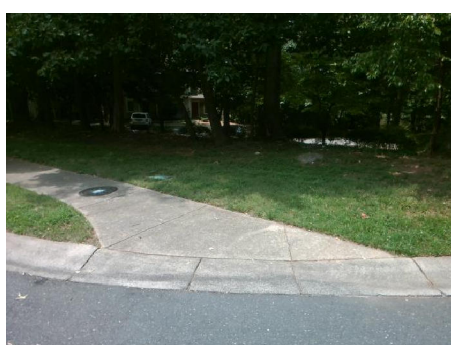
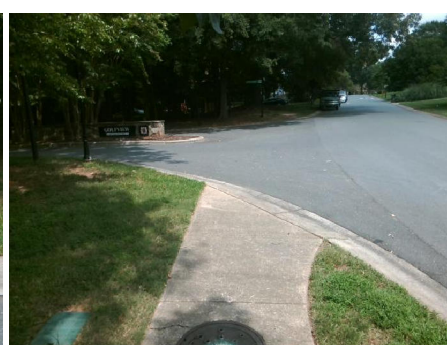
R304.5.1, R304.5.3

Compliance	Description	Data	Compliance	Description	Data
N/A	Ramp Length (in)	48.0	Yes	Ramp Slope (%)	6.5
No	Ramp Width (in)	38.0	No	Ramp XSlope (%)	4.4
N/A	Flare Type LT	N/A	N/A	Flare Type RT	N/A
N/A	Flare Slope LT (%)	N/A	N/A	Flare Slope RT (%)	N/A
N/A	Flare Traversable LT?	N/A	N/A	Flare Traversable RT?	N/A
N/A	Landing Length (in)	N/A	N/A	DWS Provided?	N/A
N/A	Landing Width (in)	N/A	N/A	DWS Contrast?	N/A
N/A	Landing Slope (%)	N/A	N/A	DWS Length (in)	N/A
N/A	Landing X Slope (%)	N/A	N/A	DWS Full Width?	N/A
N/A	Landing Curb? (Y/N)	N/A	N/A	DWS Offset (in)	N/A
N/A	Shared Landing?	N/A			
N/A	Gutter Ponding?	N/A	N/A	Gutter Slope (%)	N/A
N/A	Gutter Lip Ht (in)	N/A	N/A	Gutter X Slope (%)	N/A
N/A	Painted X Walk1?	No	N/A	Painted X Walk2?	No
	X Walk 1 Direction	To E		X Walk 2 Direction	To NE
N/A	X Walk 1 Width (in)	N/A	N/A	X Walk 2 Width (in)	N/A
	X Walk 1 Slope (%)	3.1		X Walk 2 Slope (%)	2.7
	X Walk 1 X Slope (%)	5.5		X Walk 2 X Slope (%)	0.4

N/A	Ramp inside XWalk1?	N/A	N/A	Ramp inside XWalk2?	N/A
	Road Slope (%)	2.6	N/A	Clear Space?	N/A
	Road X Slope (%)	2.6	N/A	Clear Space to XWalk (in)	N/A
N/A	Any Obstructions?	N/A	N/A	Storm Grate/Utility Hazard?	N/A
	Obstruction Type			Storm Grate/Utility Type	
		N/A			N/A
			Yes	Surface Condition? (G/P)	Good

Remove & Replace Curb Ramp With Two New Directional Ramps or Equivalent.

Total Cost: \$ 3200.00
