Access Compliance Report

Public Rights-of-Way

(Curb Ramps)

Intersection ID: 13068	Main Street: ROLAND_ST	Cross Street: TRUMAN_RD	Location: NW
ADA ID: FF03CADED6D1	Ramp Type: Perp	Initial Pass/Fail: Fail	Overall Compliance: No
Severity Score: 10			
Codes/Mitigation Info/Possible Solution		Field Measurements/Component Compliance

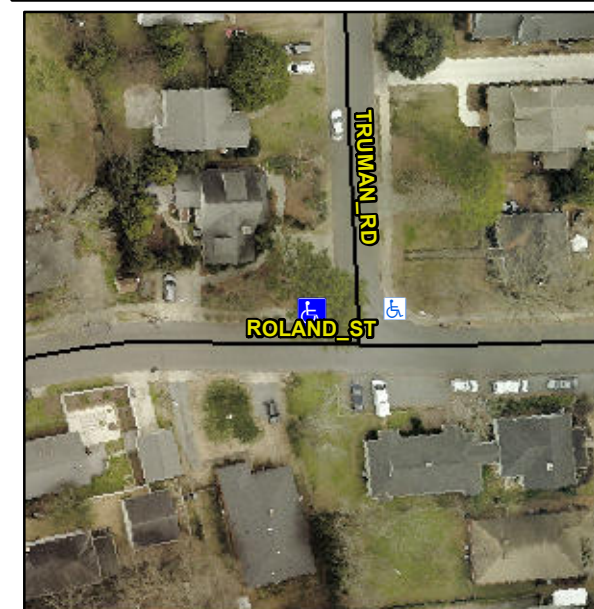
Not Found, R304.5.1, R304.5.3

Compliance	Description	Data	Compliance	Description	Data
N/A	Ramp Length (in)	59.0	Yes	Ramp Slope (%)	5.4
No	Ramp Width (in)	37.0	No	Ramp XSlope (%)	4.3
N/A	Flare Type LT	N/A	N/A	Flare Type RT	N/A
N/A	Flare Slope LT (%)	N/A	N/A	Flare Slope RT (%)	N/A
N/A	Flare Traversable LT?	N/A	N/A	Flare Traversable RT?	N/A
N/A	Landing Length (in)	N/A	N/A	DWS Provided?	N/A
N/A	Landing Width (in)	N/A	N/A	DWS Contrast?	N/A
N/A	Landing Slope (%)	N/A	N/A	DWS Length (in)	N/A
N/A	Landing X Slope (%)	N/A	N/A	DWS Full Width?	N/A
N/A	Landing Curb? (Y/N)	N/A	N/A	DWS Offset (in)	N/A
N/A	Shared Landing?	N/A			
N/A	Gutter Ponding?	N/A	N/A	Gutter Slope (%)	N/A
N/A	Gutter Lip Ht (in)	N/A	N/A	Gutter X Slope (%)	N/A
N/A	Painted X Walk1?	No	N/A	Painted X Walk2?	N/A
	X Walk 1 Direction	To E		X Walk 2 Direction	N/A
N/A	X Walk 1 Width (in)	N/A	N/A	X Walk 2 Width (in)	N/A
	X Walk 1 Slope (%)	1.3		X Walk 2 Slope (%)	N/A
	X Walk 1 X Slope (%)	3.0		X Walk 2 X Slope (%)	N/A

N/A	Ramp inside XWalk1?	N/A	N/A	Ramp inside XWalk2?	N/A
	Road Slope (%)	N/A	N/A	Clear Space?	N/A
	Road X Slope (%)	N/A	N/A	Clear Space to XWalk (in)	N/A
N/A	Any Obstructions?	N/A	N/A	Storm Grate/Utility Hazard?	N/A
	Obstruction Type			Storm Grate/Utility Type	
		N/A			N/A
		Yes		Surface Condition? (G/P)	Good

Possible Solutions:

Remove & Replace Entire Ramp.
