Access Compliance Report

Public Rights-of-Way

(Curb Ramps)

Intersection ID: 27530	Main Street: BALLANTYNE_COMMONS_PY	Cross Street: BALLANTYNE_FOREST_DR	Location: SW
ADA ID: FF17E10239EF	Ramp Type: Perp	Initial Pass/Fail: Fail	Overall Compliance: No
Severity Score: 30			
Codes/Mitigation Info/Possible Solution		Field Measurements/Component Compliance

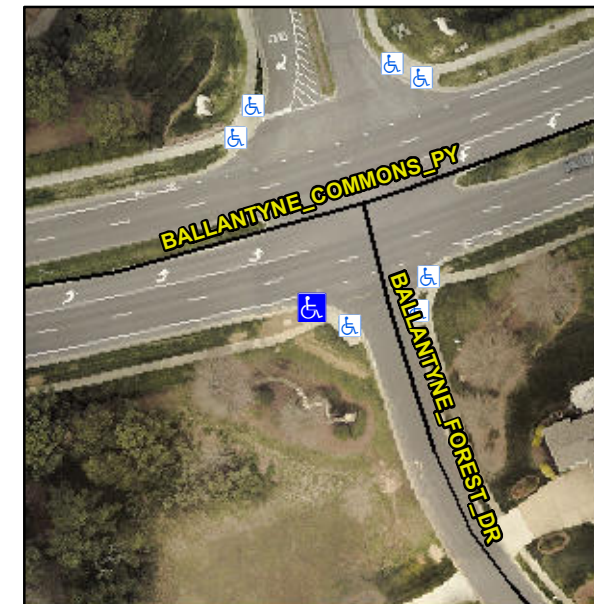
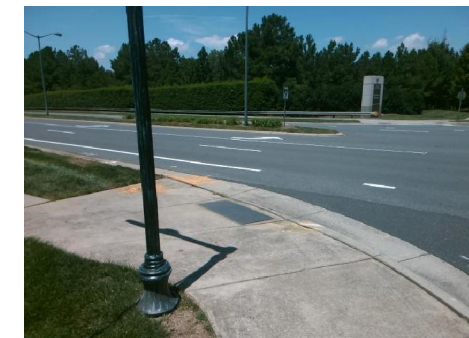
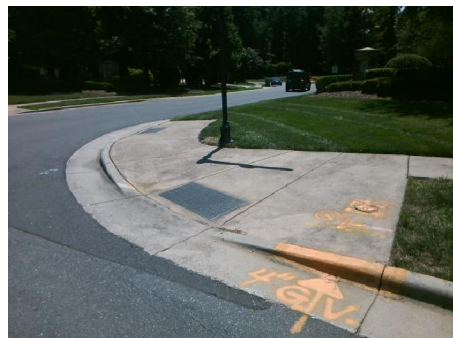
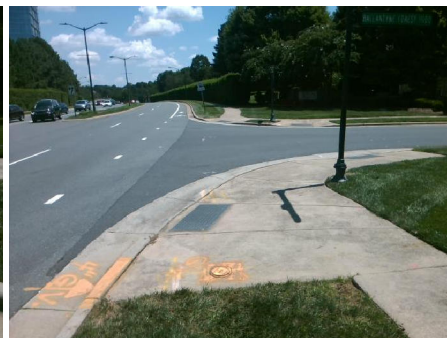
R304.5.1, R304.2.2

Compliance	Description	Data	Compliance	Description	Data
N/A	Ramp Length (in)	120.0	No	Ramp Slope (%)	9.2
No	Ramp Width (in)	33.0	Yes	Ramp XSlope (%)	1.3
N/A	Flare Type LT	N/A	N/A	Flare Type RT	N/A
N/A	Flare Slope LT (%)	N/A	N/A	Flare Slope RT (%)	N/A
N/A	Flare Traversable LT?	N/A	N/A	Flare Traversable RT?	N/A
N/A	Landing Length (in)	N/A	N/A	DWS Provided?	N/A
N/A	Landing Width (in)	N/A	N/A	DWS Contrast?	N/A
N/A	Landing Slope (%)	N/A	N/A	DWS Length (in)	N/A
N/A	Landing X Slope (%)	N/A	N/A	DWS Full Width?	N/A
N/A	Landing Curb? (Y/N)	N/A	N/A	DWS Offset (in)	N/A
N/A	Shared Landing?	N/A			
N/A	Gutter Ponding?	N/A	N/A	Gutter Slope (%)	N/A
N/A	Gutter Lip Ht (in)	N/A	N/A	Gutter X Slope (%)	N/A
N/A	Painted X Walk1?	No	N/A	Painted X Walk2?	N/A
	X Walk 1 Direction	To NW		X Walk 2 Direction	N/A
N/A	X Walk 1 Width (in)	N/A	N/A	X Walk 2 Width (in)	N/A
	X Walk 1 Slope (%)	2.3		X Walk 2 Slope (%)	N/A
	X Walk 1 X Slope (%)	0.1		X Walk 2 X Slope (%)	N/A

N/A	Ramp inside XWalk1?	N/A	N/A	Ramp inside XWalk2?	N/A
	Road Slope (%)	N/A	N/A	Clear Space?	N/A
	Road X Slope (%)	N/A	N/A	Clear Space to XWalk (in)	N/A
N/A	Any Obstructions?	N/A	N/A	Storm Grate/Utility Hazard?	N/A
	Obstruction Type			Storm Grate/Utility Type	
		N/A			N/A
			Yes	Surface Condition? (G/P)	Good

Remove & Replace Entire Ramp.
