# Access Compliance Report

## Public Rights-of-Way

### (Curb Ramps)

Intersection ID: 26010	Main Street: JOHNSTON_RD	Cross Street: RENAISSANCE_CT	Location: SE
ADA ID: FF1BBBA0E474	Ramp Type: PerpDiag	Initial Pass/Fail: Fail	Overall Compliance: No
Severity Score: 46.25			
Codes/Mitigation Info/Possible Solution		Field Measurements/Component Compliance

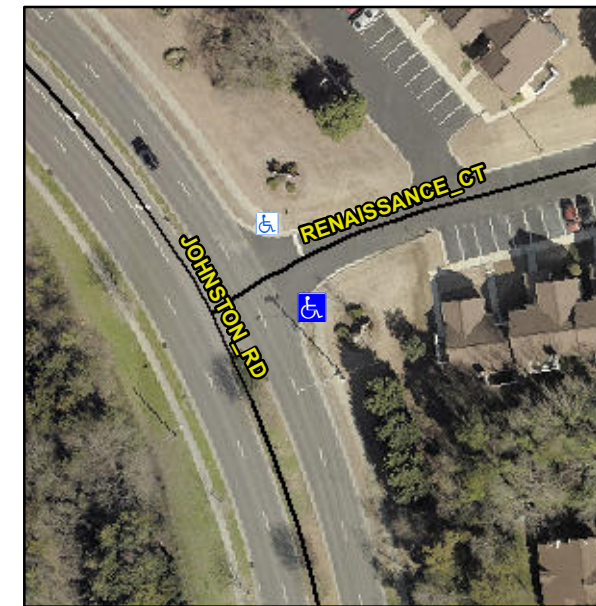
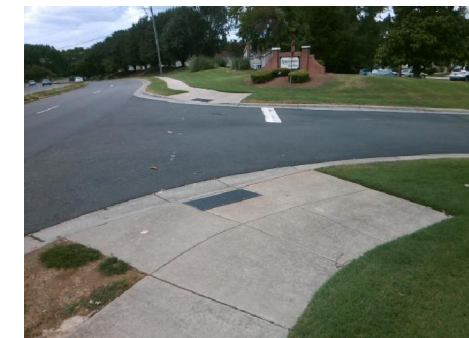
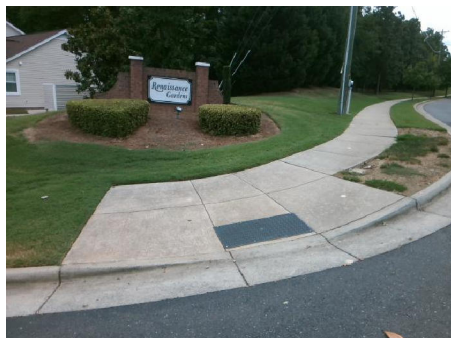
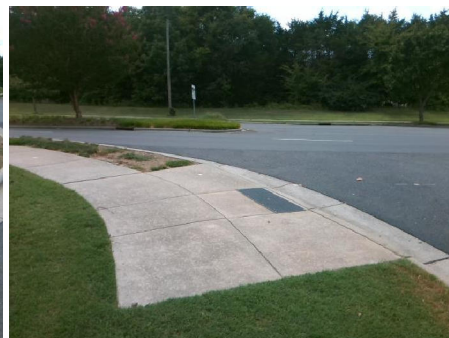
**Not Found, R304.5.1, R304.2.2, R304.5.3**

Compliance	Description	Data	Compliance	Description	Data
N/A	Ramp Length (in)	60.0	No	Ramp Slope (%)	9.1
No	Ramp Width (in)	42.0	No	Ramp XSlope (%)	9.0
N/A	Flare Type LT	N/A	N/A	Flare Type RT	N/A
N/A	Flare Slope LT (%)	N/A	N/A	Flare Slope RT (%)	N/A
N/A	Flare Traversable LT?	N/A	N/A	Flare Traversable RT?	N/A
N/A	Landing Length (in)	N/A	N/A	DWS Provided?	N/A
N/A	Landing Width (in)	N/A	N/A	DWS Contrast?	N/A
N/A	Landing Slope (%)	N/A	N/A	DWS Length (in)	N/A
N/A	Landing X Slope (%)	N/A	N/A	DWS Full Width?	N/A
N/A	Landing Curb? (Y/N)	N/A	N/A	DWS Offset (in)	N/A
N/A	Shared Landing?	N/A			
N/A	Gutter Ponding?	N/A	N/A	Gutter Slope (%)	N/A
N/A	Gutter Lip Ht (in)	N/A	N/A	Gutter X Slope (%)	N/A
N/A	Painted X Walk1?	No	N/A	Painted X Walk2?	No
	X Walk 1 Direction	To NE		X Walk 2 Direction	To NW
N/A	X Walk 1 Width (in)	N/A	N/A	X Walk 2 Width (in)	N/A
	X Walk 1 Slope (%)	1.5		X Walk 2 Slope (%)	7.5
	X Walk 1 X Slope (%)	7.5		X Walk 2 X Slope (%)	0.1

N/A	Ramp inside XWalk1?	N/A	N/A	Ramp inside XWalk2?	N/A
	Road Slope (%)	7.6	N/A	Clear Space?	N/A
	Road X Slope (%)	7.7	N/A	Clear Space to XWalk (in)	N/A
N/A	Any Obstructions?	N/A	N/A	Storm Grate/Utility Hazard?	N/A
	Obstruction Type			Storm Grate/Utility Type	
		N/A			N/A
			Yes	Surface Condition? (G/P)	Good

**Remove & Replace Curb Ramp With Two New Directional Ramps or Equivalent.**
