Access Compliance Report Public Rights-of-Way (Curb Ramps)

Main Street: BURCH DR **Cross Street: DISTRIBUTION CENTER DR** Location: Intersection ID: 7368 SE ADA ID: FF29825E0B20 Ramp Type: Perp Severity Score: 21.25 Initial Pass/Fail: Fail **Overall Compliance: No**

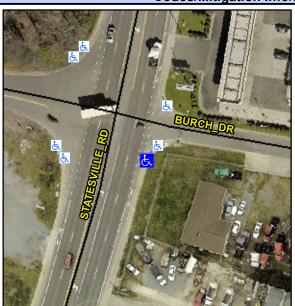
- 1010 1110
-	Possible Solutions:	Compli	ance	Description
	Remove & Replace Entire Ramp.	N/A	Ramp	Length (in)
Ī	·	No	Ramp	Width (in)
		N/A	Flare	Type LT
g		N/A	Flare	Slope LT (%)
1		N/A	Flare	Traversable LT
Ę		N/A	Landi	ng Length (in)
	Surveyor Notes:	N/A	Landi	ng Width (in)
8	N/A	N/A	Landi	ng Slope (%)
1		N/A	Landi	ng X Slope (%
		N/A	Landi	ng Curb? (Y/N
		N/A	Share	d Landing?
	PROW/ADA:	N/A	Gutte	r Ponding?
į	Not Found, R304.5.1, R304.2.2	N/A	Gutte	r Lip Ht (in)
		N/A	Painte	ed X Walk1?
			X Wal	k 1 Direction
		N/A	X Wal	k 1 Width (in)
			X Wal	k 1 Slope (%)
			X Wal	k 1 X Slope (%
		N/A	Ramp	inside XWalk
			Road	Slope (%)

Surveyor Notes:				N/A
N/A				N/A
				N/A
				N/A
				N/A
PROW/ADA:				N/A
Not Found,	R304.5.1, R304.2.	2		N/A
,	•			N/A
				N/A
				N/A
				N/A
Total Cost:	\$		1850.00
