## Access Compliance Report Public Rights-of-Way (Curb Ramps)

Intersection ID: 25033 Main Street: ARBORETUM\_VIEW Cross Street: PINEVILLE-MATTHEWS\_RD Location: SE

ADA ID: FF2BFC64DB19 Ramp Type: PerpDiag Initial Pass/Fail: Fail Overall Compliance: No Severity Score: 22.5

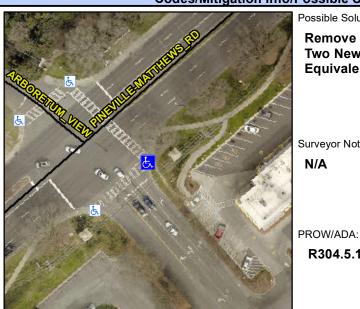
Compliance Description Data		Compliance Description		Data	
N/A	Ramp Length (in)	64.0	No	Ramp Slope (%)	8.4
No	Ramp Width (in)	41.0	No	Ramp XSlope (%)	4.3
N/A	Flare Type LT	N/A	N/A	Flare Type RT	N/A
N/A	Flare Slope LT (%)	N/A	N/A	Flare Slope RT (%)	N/A
N/A	Flare Traversable LT?	N/A	N/A	Flare Traversable RT?	N/A
N/A	Landing Length (in)	N/A	N/A	DWS Provided?	N/A
N/A	Landing Width (in)	N/A	N/A	DWS Contrast?	N/A
N/A	Landing Slope (%)	N/A	N/A	DWS Length (in)	N/A
N/A	Landing X Slope (%)	N/A	N/A	DWS Full Width?	N/A
N/A	Landing Curb? (Y/N)	N/A	N/A	DWS Offset (in)	N/A
N/A	Shared Landing?	N/A			
N/A	Gutter Ponding?	N/A	N/A	Gutter Slope (%)	N/A
N/A	Gutter Lip Ht (in)	N/A	N/A	Gutter X Slope (%)	N/A
N/A	Painted X Walk1?	Yes	N/A	Painted X Walk2?	Yes
	X Walk 1 Direction	To NW		X Walk 2 Direction	To SW
N/A	X Walk 1 Width (in)	106.0	N/A	X Walk 2 Width (in)	106.0
	X Walk 1 Slope (%)	0.1		X Walk 2 Slope (%)	1.3
	X Walk 1 X Slope (%)	4.7		X Walk 2 X Slope (%)	3.1

N/A	Ramp inside XWalk1?	Yes	N/A	Ramp inside XWalk2?	Yes
	Road Slope (%)	3.4	N/A	Clear Space?	N/A
	Road X Slope (%)	1.0	N/A	Clear Space to XWalk (in)	N/A
N/A	Any Obstructions?	N/A	N/A	Storm Grate/Utility Hazard?	N/A
	Obstruction Type		l	Storm Grate/Utility Type	
		N/A			N/A

Remove & Replace Curb Ramp With Two New Directional Ramps or Equivalent.

R304.5.1, R304.2.2, R304.5.3
