Access Compliance Report

Public Rights-of-Way

(Curb Ramps)

Intersection ID: 16126	Main Street: E_W_T_HARRIS_BV	Cross Street: IDLEWILD_RD	Location: SE
ADA ID: FF31BFB9E05F	Ramp Type: Perp	Initial Pass/Fail: Fail	Overall Compliance: No
			Severity Score: 13.75

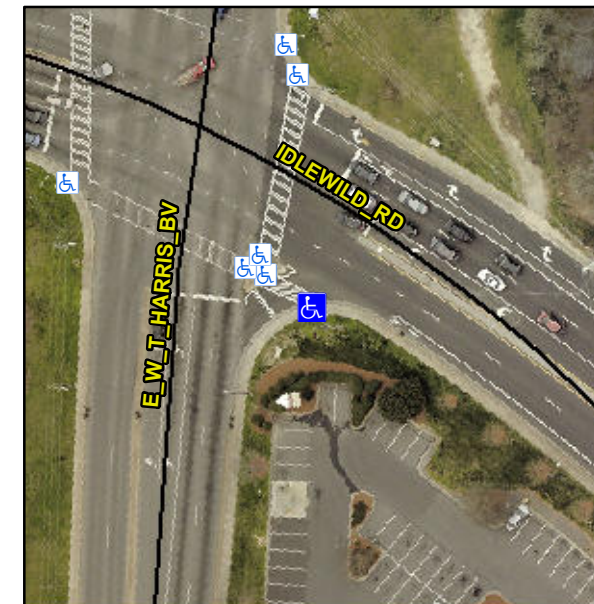
Not Found, R304.2.2, R304.5.3

Compliance	Description	Data	Compliance	Description	Data
N/A	Ramp Length (in)	59.0	No	Ramp Slope (%)	9.4
Yes	Ramp Width (in)	48.0	No	Ramp XSlope (%)	2.3
N/A	Flare Type LT	N/A	N/A	Flare Type RT	N/A
N/A	Flare Slope LT (%)	N/A	N/A	Flare Slope RT (%)	N/A
N/A	Flare Traversable LT?	N/A	N/A	Flare Traversable RT?	N/A
N/A	Landing Length (in)	N/A	N/A	DWS Provided?	N/A
N/A	Landing Width (in)	N/A	N/A	DWS Contrast?	N/A
N/A	Landing Slope (%)	N/A	N/A	DWS Length (in)	N/A
N/A	Landing X Slope (%)	N/A	N/A	DWS Full Width?	N/A
N/A	Landing Curb? (Y/N)	N/A	N/A	DWS Offset (in)	N/A
N/A	Shared Landing?	N/A			
N/A	Gutter Ponding?	N/A	N/A	Gutter Slope (%)	N/A
N/A	Gutter Lip Ht (in)	1.0	N/A	Gutter X Slope (%)	N/A
N/A	Painted X Walk1?	Yes	N/A	Painted X Walk2?	N/A
	X Walk 1 Direction	To NW		X Walk 2 Direction	N/A
N/A	X Walk 1 Width (in)	74.0	N/A	X Walk 2 Width (in)	N/A
	X Walk 1 Slope (%)	2.3		X Walk 2 Slope (%)	N/A
	X Walk 1 X Slope (%)	4.1		X Walk 2 X Slope (%)	N/A

N/A	Ramp inside XWalk1?	Yes	N/A	Ramp inside XWalk2?	N/A
	Road Slope (%)	N/A	N/A	Clear Space?	N/A
	Road X Slope (%)	N/A	N/A	Clear Space to XWalk (in)	N/A
N/A	Any Obstructions?	N/A	N/A	Storm Grate/Utility Hazard?	N/A
	Obstruction Type			Storm Grate/Utility Type	
		N/A			N/A
			Yes	Surface Condition? (G/P)	Good

Remove & Replace Entire Ramp.
