Access Compliance Report

Public Rights-of-Way

(Curb Ramps)

Intersection ID: 42962	Main Street: MOORES_CHAPEL_RD	Cross Street: RED_ROBIN_ST	Location: E
ADA ID: FF366D7C15EF	Ramp Type: Para	Initial Pass/Fail: Fail	Overall Compliance: No
Codes/Mitigation Info/Possible Solution		Field Measurements/Component Compliance

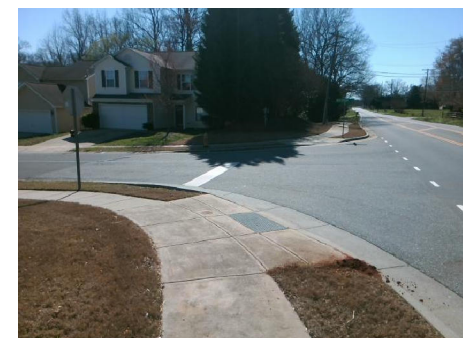
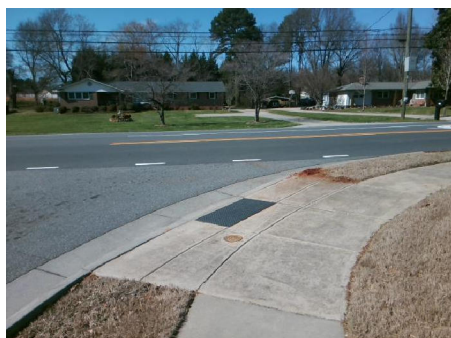
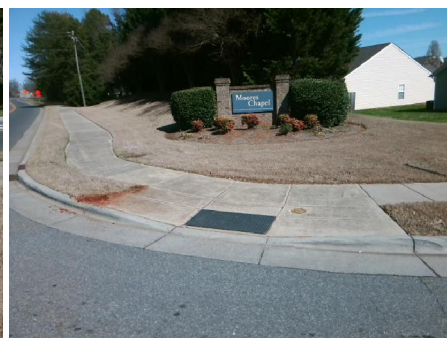
RT RP < 5%

R304.3.2, R304.5.3

Compliance	Description	Data	Compliance	Description	Data
N/A	Ramp Length LT (in)	47.0	N/A	Ramp Length RT (in)	47.0
Yes	Ramp Width LT (in)	48.0	Yes	Ramp Width RT (in)	48.0
No	Ramp Slope LT (%)	8.5	Yes	Ramp Slope RT (%)	3.0
Yes	Ramp XSlope LT (%)	0.1	No	Ramp XSlope RT (%)	2.1
N/A	Landing Length (in)	N/A	N/A	DWS Provided?	N/A
N/A	Landing Width (in)	N/A	N/A	DWS Contrast?	N/A
N/A	Landing Slope (%)	N/A	N/A	DWS Length (in)	N/A
N/A	Landing X Slope (%)	N/A	N/A	DWS Full Width?	N/A
N/A	Landing Curb? (Y/N)	N/A	N/A	DWS Offset (in)	N/A
N/A	Shared Landing?	N/A			
N/A	Gutter Ponding?	N/A	N/A	Gutter Slope (%)	N/A
N/A	Gutter Lip Ht (in)	N/A	N/A	Gutter X Slope (%)	N/A
N/A	Painted X Walk1?	No	N/A	Painted X Walk2?	N/A
	X Walk 1 Direction	To SW		X Walk 2 Direction	N/A
N/A	X Walk 1 Width (in)	N/A	N/A	X Walk 2 Width (in)	N/A
	X Walk 1 Slope (%)	1.2		X Walk 2 Slope (%)	N/A
	X Walk 1 X Slope (%)	5.7		X Walk 2 X Slope (%)	N/A
N/A	Ramp inside XWalk1?	N/A	N/A	Ramp inside XWalk2?	N/A

Road Slope (%)	N/A	N/A	Clear Space?	N/A
	Road X Slope (%)	N/A	N/A	Clear Space to XWalk (in)	N/A
N/A	Any Obstructions?	N/A	N/A	Storm Grate/Utility Hazard?	N/A
	Obstruction Type			Storm Grate/Utility Type	
		N/A			N/A
			Yes	Surface Condition? (G/P)	Good
			N/A	Curb Slope (%)	5.1

Remove & Replace Entire Ramp.

Total Cost: \$ 1600.00
