Access Compliance Report

Public Rights-of-Way

(Curb Ramps)

Intersection ID: 12160	Main Street: E_9TH_ST	Cross Street: N_BREVARD_ST	Location: S
ADA ID: FF368B769378	Ramp Type: PerpDiag	Initial Pass/Fail: Fail	Overall Compliance: No
		Severity Score: 8.75

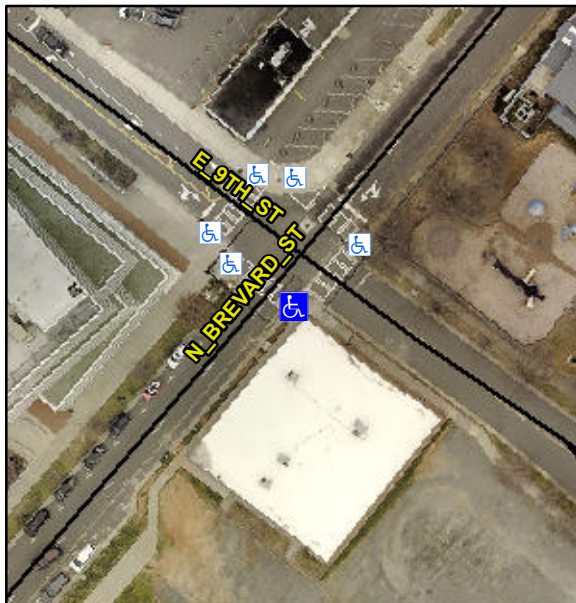
Compliance	Description	Data	Compliance	Description	Data
N/A	Ramp Length (in)	72.0	Yes	Ramp Slope (%)	7.7
No	Ramp Width (in)	47.0	Yes	Ramp XSlope (%)	0.0
N/A	Flare Type LT	N/A	N/A	Flare Type RT	N/A
N/A	Flare Slope LT (%)	N/A	N/A	Flare Slope RT (%)	N/A
N/A	Flare Traversable LT?	N/A	N/A	Flare Traversable RT?	N/A
N/A	Landing Length (in)	N/A	N/A	DWS Provided?	N/A
N/A	Landing Width (in)	N/A	N/A	DWS Contrast?	N/A
N/A	Landing Slope (%)	N/A	N/A	DWS Length (in)	N/A
N/A	Landing X Slope (%)	N/A	N/A	DWS Full Width?	N/A
N/A	Landing Curb? (Y/N)	N/A	N/A	DWS Offset (in)	N/A
N/A	Shared Landing?	N/A			
N/A	Gutter Ponding?	N/A	N/A	Gutter Slope (%)	N/A
N/A	Gutter Lip Ht (in)	N/A	N/A	Gutter X Slope (%)	N/A
N/A	Painted X Walk1?	Yes	N/A	Painted X Walk2?	Yes
	X Walk 1 Direction	To NE		X Walk 2 Direction	To NW
N/A	X Walk 1 Width (in)	115.0	N/A	X Walk 2 Width (in)	117.0
	X Walk 1 Slope (%)	5.4		X Walk 2 Slope (%)	3.3
	X Walk 1 X Slope (%)	1.6		X Walk 2 X Slope (%)	1.3

N/A	Ramp inside XWalk1?	Yes	N/A	Ramp inside XWalk2?	Yes
	Road Slope (%)	1.6	N/A	Clear Space?	N/A
	Road X Slope (%)	3.9	N/A	Clear Space to XWalk (in)	N/A
N/A	Any Obstructions?	N/A	N/A	Storm Grate/Utility Hazard?	N/A
	Obstruction Type			Storm Grate/Utility Type	
		N/A			N/A
			Yes	Surface Condition? (G/P)	Good

Possible Solutions:

Remove & Replace Curb Ramp With Two New Directional Ramps or Equivalent.

R304.5.1
