# Access Compliance Report

## Public Rights-of-Way

### (Curb Ramps)

Intersection ID: 13586	Main Street: E_7TH_ST	Cross Street: ARMORY_DR	Location: SW
ADA ID: FF3C3E38A8B7	Ramp Type: Directional1	Initial Pass/Fail: Fail	Overall Compliance: No
			Severity Score: 13.75

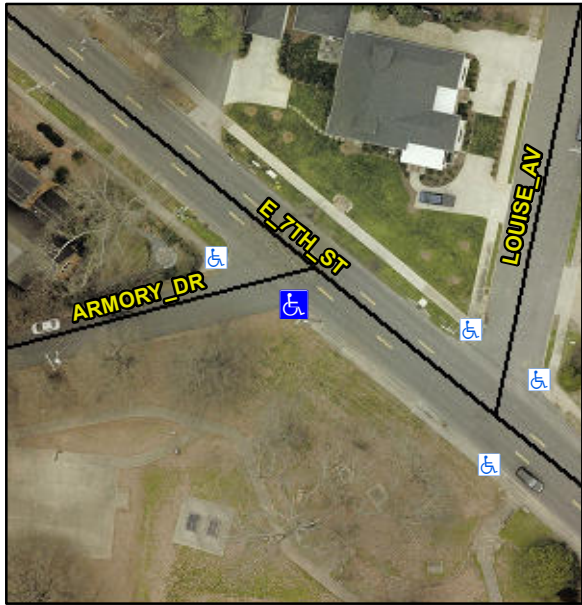
Possible Solutions:		Compliance	Description	Data	Compliance	Description	Data
	Remove & Replace Entire Ramp.		N/A	Ramp Length (in)	27.0	N/A	Grade Break?	N/A
			Yes	Ramp Width (in)	69.0	N/A	Grade Break Slope (%)	0.0
			No	Ramp Slope (%)	8.6	N/A	Grade Break XSlope (%)	0.0
			No	Ramp XSlope (%)	3.1			
			N/A	Flare Type LT	N/A	N/A	Flare Type RT	N/A
			N/A	Flare Slope LT (%)	N/A	N/A	Flare Slope RT (%)	0.0
			N/A	Flare Traversable LT?	N/A	N/A	Flare Traversable RT?	N/A
			N/A	Landing Length (in)	0.0	N/A	DWS Provided?	N/A
			N/A	Landing Width (in)	0.0	N/A	DWS Contrast?	N/A
Surveyor Notes:			N/A	Landing Slope (%)	0.0	N/A	DWS Length (in)	N/A
N/A			N/A	Landing X Slope (%)	0.0	N/A	DWS Full Width?	N/A
PROW/ADA:			N/A	Landing Curb? (Y/N)	N/A	N/A	DWS Offset LT (in)	N/A
R304.2.2, R304.5.3			N/A	Shared Landing?	N/A	N/A	DWS Offset RT (in)	N/A

N/A	Gutter Ponding?	0.0	N/A	Gutter Slope (%)	N/A
			N/A	Gutter Lip Ht (in)	0.5	N/A	Gutter X Slope (%)	N/A
			N/A	Painted X Walk1?	No		Road Slope (%)	3.1
				X Walk 1 Direction	To NW		Road X Slope (%)	1.5
				X Walk 1 Width (in)	N/A		Clear Space?	N/A
				X Walk 1 Slope (%)	3.1	N/A	Clear Space to XWalk (in)	N/A
				X Walk 1 X Slope (%)	1.5	N/A	Storm Grate/Utility Hazard?	N/A
			N/A	Ramp inside XWalk1?	N/A		Storm Grate/Utility Type	
			N/A	Any Obstructions?	N/A			N/A
				Obstruction Type		Yes	Surface Condition? (G/P)	Good
						N/A	Curb Slope (%)	11.3
Total Cost:		\$ 1600.00						
Street 1 Name		ARMORY DR						
Stop Condition-Street 1		StopSign						
Street 2 Name		N/A						
Stop Condition-Street 2		N/A
