Access Compliance Report

Public Rights-of-Way

(Curb Ramps)

Intersection ID: N/A	Main Street: STATESVILLE_RD	Cross Street: N/A	Location: SW
ADA ID: FF4DCE8A1821	Ramp Type: Directional1	Initial Pass/Fail: Fail	Overall Compliance: No
		Severity Score: 1.25

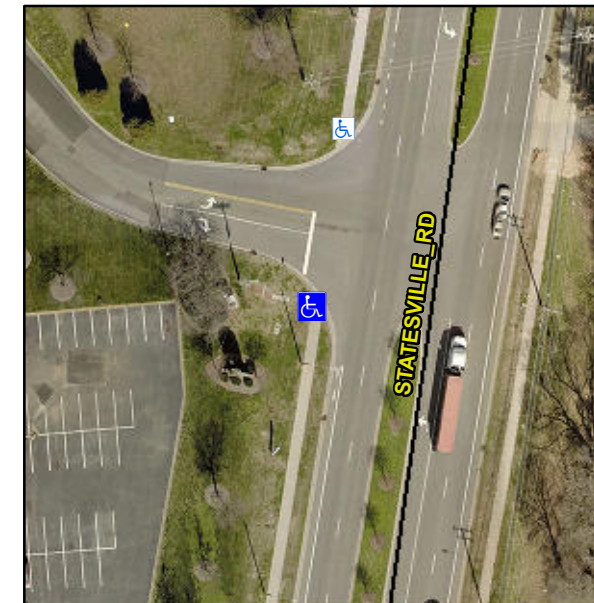
R304.5.3

Compliance	Description	Data	Compliance	Description	Data
N/A	Ramp Length (in)	73.0	N/A	Grade Break?	N/A
Yes	Ramp Width (in)	67.0	N/A	Grade Break Slope (%)	0.0
Yes	Ramp Slope (%)	7.3	N/A	Grade Break XSlope (%)	0.0
No	Ramp XSlope (%)	3.5			
N/A	Flare Type LT	N/A	N/A	Flare Type RT	N/A
N/A	Flare Slope LT (%)	N/A	N/A	Flare Slope RT (%)	0.0
N/A	Flare Traversable LT?	N/A	N/A	Flare Traversable RT?	N/A
N/A	Landing Length (in)	0.0	N/A	DWS Provided?	N/A
N/A	Landing Width (in)	0.0	N/A	DWS Contrast?	N/A
N/A	Landing Slope (%)	0.0	N/A	DWS Length (in)	N/A
N/A	Landing X Slope (%)	0.0	N/A	DWS Full Width?	N/A
N/A	Landing Curb? (Y/N)	N/A	N/A	DWS Offset LT (in)	N/A
N/A	Shared Landing?	N/A	N/A	DWS Offset RT (in)	N/A
N/A	Gutter Ponding?	0.0	N/A	Gutter Slope (%)	N/A
N/A	Gutter Lip Ht (in)	0.0	N/A	Gutter X Slope (%)	N/A
N/A	Painted X Walk1?	No		Road Slope (%)	0.1
	X Walk 1 Direction	To NW		Road X Slope (%)	0.7
	X Walk 1 Width (in)	N/A		Clear Space?	N/A

X Walk 1 Slope (%)	0.1	N/A	Clear Space to XWalk (in)	N/A
	X Walk 1 X Slope (%)	0.7	N/A	Storm Grate/Utility Hazard?	N/A
N/A	Ramp inside XWalk1?	N/A		Storm Grate/Utility Type	
N/A	Any Obstructions?	N/A			N/A
	Obstruction Type		Yes	Surface Condition? (G/P)	Good
			N/A	Curb Slope (%)	4.7

Possible Solutions:

Remove & Replace Entire Ramp.

Total Cost: \$ 1600.00
