Access Compliance Report Public Rights-of-Way (Curb Ramps)

Intersection ID: 10584	Main Street: COXE_AV			Cross Street: S_TURNER_AV				Location:	N
ADA ID: FF4EB1006663	Ramp Type: Perp			Initial Pass/Fail: Fail Overall Compliance: No				o Severity Score:	13.75
Codes/Mitigation Info/Possible Solution				Field Measurements/Component Compliance					
		Possible Solutions:					liance Description	Data	
	3	Remove & Replace Entire Ram	p.	N/A	Ramp Length (in)	100.5	No	Ramp Slope (%)	9.1
				Yes	Ramp Width (in)	64.0	No	Ramp XSlope (%)	4.0
				N/A	Flare Type LT	N/A	N/A	Flare Type RT	N/A
	A-			N/A	Flare Slope LT (%)	N/A	N/A	Flare Slope RT (%)	N/A
	adding ?			N/A	Flare Traversable LT?	N/A	N/A	Flare Traversable RT?	N/A
				N/A	Landing Length (in)	N/A	N/A	DWS Provided?	N/A
	N	Surveyor Notes:		N/A	Landing Width (in)	N/A	N/A	DWS Contrast?	N/A
	Last and the set	N/A		N/A	Landing Slope (%)	N/A	N/A	DWS Length (in)	N/A
E	States and			N/A	Landing X Slope (%)	N/A	N/A	DWS Full Width?	N/A

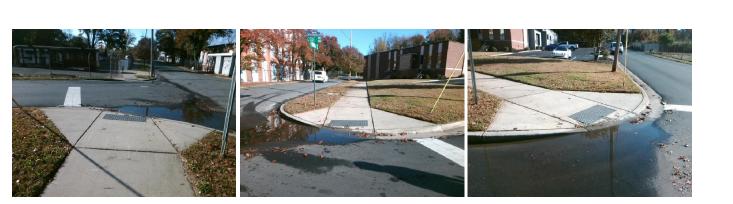
0 b				N/A	Landing Curb? (Y/N)	N/A	N/A	DWS Offset (in)	N/A
ALL MALE				N/A	Shared Landing?	N/A			
Service States		PROW/ADA:		N/A	Gutter Ponding?	Yes	N/A	Gutter Slope (%)	N/A
	A State of the second	Not Found, R304.2.2, R304.5.3		N/A	Gutter Lip Ht (in)	N/A	N/A	Gutter X Slope (%)	N/A
Same and Martin				N/A	Painted X Walk1?	No	N/A	Painted X Walk2?	N/A
	A A A A A				X Walk 1 Direction	To SW		X Walk 2 Direction	N/A
				N/A	X Walk 1 Width (in)	N/A	N/A	X Walk 2 Width (in)	N/A
Street 1 Name	COXE AV				X Walk 1 Slope (%)	0.8		X Walk 2 Slope (%)	N/A
Stop Condition-Street 2	StopSign				X Walk 1 X Slope (%)	1.5		X Walk 2 X Slope (%)	N/A
Street 2 Name	N/A			N/A	Ramp inside XWalk1?	N/A	N/A	Ramp inside XWalk2?	N/A
Stop Condition-Street 1	N/A				Road Slope (%)	N/A	N/A	Clear Space?	N/A
					Road X Slope (%)	N/A	N/A	Clear Space to XWalk (in)	N/A
				N/A	Any Obstructions?	N/A	N/A	Storm Grate/Utility Hazard?	N/A
		Total Cost: \$	1850.00		Obstruction Type			Storm Grate/Utility Type

Yes Surface Condition? (G/P)

Good
