# Access Compliance Report

## Public Rights-of-Way

### (Curb Ramps)

Intersection ID: 46814	Main Street: OLDE_IVY_WY	Cross Street: RED_BIRCH_DR	Location:	N
ADA ID: FF568BA73389	Ramp Type: Perp	Initial Pass/Fail: Fail	Overall Compliance: No	Severity Score: 10
Codes/Mitigation Info/Possible Solution		Field Measurements/Component Compliance

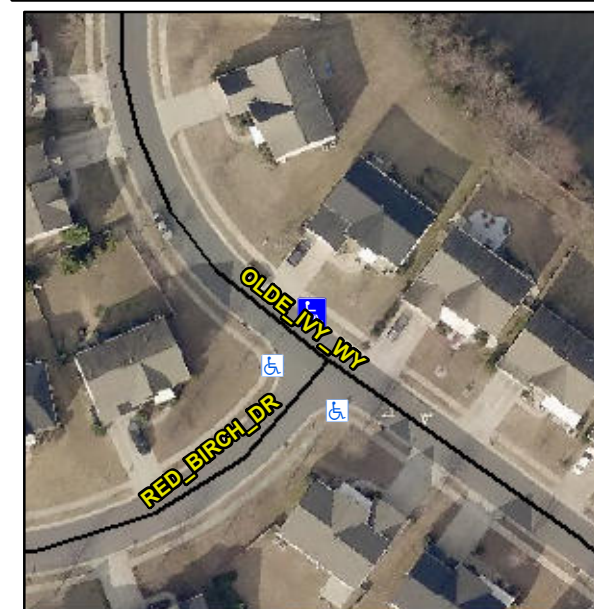
**Not Found, R304.5.1, R304.5.3**

Compliance	Description	Data	Compliance	Description	Data
N/A	Ramp Length (in)	47.0	Yes	Ramp Slope (%)	6.3
No	Ramp Width (in)	46.5	No	Ramp XSlope (%)	2.4
N/A	Flare Type LT	N/A	N/A	Flare Type RT	N/A
N/A	Flare Slope LT (%)	N/A	N/A	Flare Slope RT (%)	N/A
N/A	Flare Traversable LT?	N/A	N/A	Flare Traversable RT?	N/A
N/A	Landing Length (in)	N/A	N/A	DWS Provided?	N/A
N/A	Landing Width (in)	N/A	N/A	DWS Contrast?	N/A
N/A	Landing Slope (%)	N/A	N/A	DWS Length (in)	N/A
N/A	Landing X Slope (%)	N/A	N/A	DWS Full Width?	N/A
N/A	Landing Curb? (Y/N)	N/A	N/A	DWS Offset (in)	N/A
N/A	Shared Landing?	N/A			
N/A	Gutter Ponding?	N/A	N/A	Gutter Slope (%)	N/A
N/A	Gutter Lip Ht (in)	N/A	N/A	Gutter X Slope (%)	N/A
N/A	Painted X Walk1?	No	N/A	Painted X Walk2?	N/A
	X Walk 1 Direction	To SW		X Walk 2 Direction	N/A
N/A	X Walk 1 Width (in)	N/A	N/A	X Walk 2 Width (in)	N/A
	X Walk 1 Slope (%)	5.5		X Walk 2 Slope (%)	N/A
	X Walk 1 X Slope (%)	2.1		X Walk 2 X Slope (%)	N/A

N/A	Ramp inside XWalk1?	N/A	N/A	Ramp inside XWalk2?	N/A
	Road Slope (%)	N/A	N/A	Clear Space?	N/A
	Road X Slope (%)	N/A	N/A	Clear Space to XWalk (in)	N/A
N/A	Any Obstructions?	N/A	N/A	Storm Grate/Utility Hazard?	N/A
	Obstruction Type			Storm Grate/Utility Type	
		N/A			N/A
			Yes	Surface Condition? (G/P)	Good

**Remove & Replace Entire Ramp.**

Total Cost: \$ 1850.00
