Access Compliance Report

Public Rights-of-Way

(Curb Ramps)

Intersection ID: 13709	Main Street: SHENANDOAH_AV	Cross Street: ST_JULIEN_ST	Location: E
ADA ID: FF612D2199AC	Ramp Type: PerpDiag	Initial Pass/Fail: Fail	Overall Compliance: No
Severity Score: 21.25			
Codes/Mitigation Info/Possible Solution		Field Measurements/Component Compliance

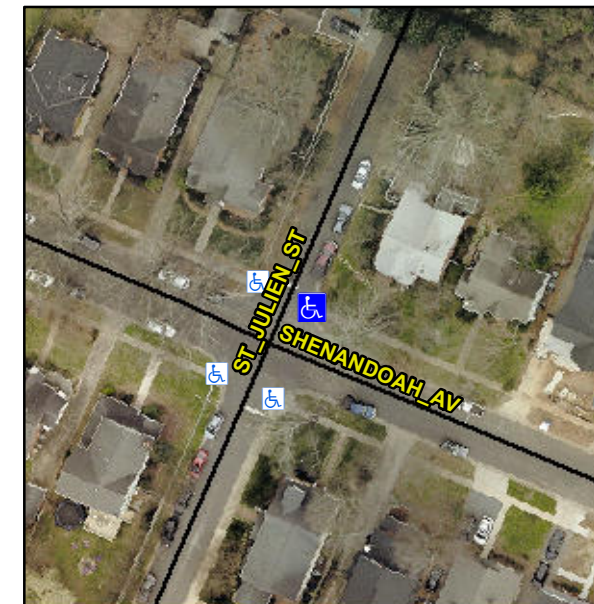
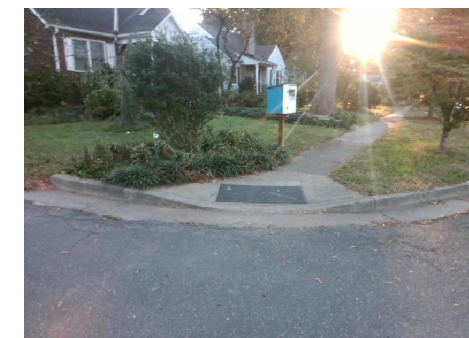
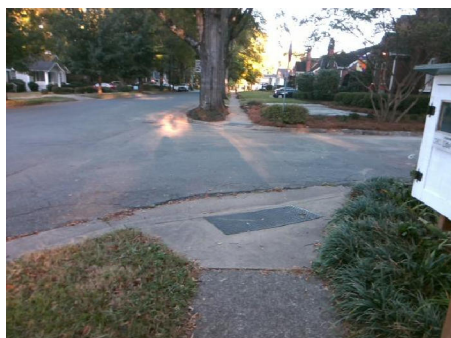
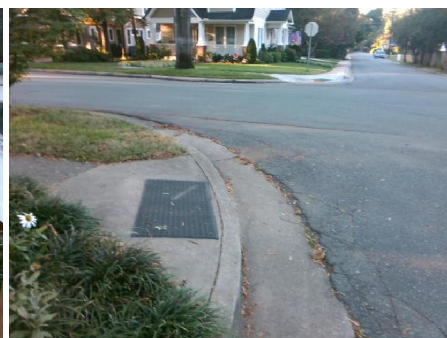
Not Found, R304.5.1, R304.2.2

Compliance	Description	Data	Compliance	Description	Data
N/A	Ramp Length (in)	56.0	No	Ramp Slope (%)	9.3
No	Ramp Width (in)	40.0	Yes	Ramp XSlope (%)	1.9
N/A	Flare Type LT	N/A	N/A	Flare Type RT	N/A
N/A	Flare Slope LT (%)	N/A	N/A	Flare Slope RT (%)	N/A
N/A	Flare Traversable LT?	N/A	N/A	Flare Traversable RT?	N/A
N/A	Landing Length (in)	N/A	N/A	DWS Provided?	N/A
N/A	Landing Width (in)	N/A	N/A	DWS Contrast?	N/A
N/A	Landing Slope (%)	N/A	N/A	DWS Length (in)	N/A
N/A	Landing X Slope (%)	N/A	N/A	DWS Full Width?	N/A
N/A	Landing Curb? (Y/N)	N/A	N/A	DWS Offset (in)	N/A
N/A	Shared Landing?	N/A			
N/A	Gutter Ponding?	N/A	N/A	Gutter Slope (%)	N/A
N/A	Gutter Lip Ht (in)	2.0	N/A	Gutter X Slope (%)	N/A
N/A	Painted X Walk1?	No	N/A	Painted X Walk2?	No
	X Walk 1 Direction	To NW		X Walk 2 Direction	To SW
N/A	X Walk 1 Width (in)	N/A	N/A	X Walk 2 Width (in)	N/A
	X Walk 1 Slope (%)	1.8		X Walk 2 Slope (%)	1.4
	X Walk 1 X Slope (%)	1.0		X Walk 2 X Slope (%)	0.1

N/A	Ramp inside XWalk1?	N/A	N/A	Ramp inside XWalk2?	N/A
	Road Slope (%)	1.1	N/A	Clear Space?	N/A
	Road X Slope (%)	0.9	N/A	Clear Space to XWalk (in)	N/A
N/A	Any Obstructions?	N/A	N/A	Storm Grate/Utility Hazard?	N/A
	Obstruction Type			Storm Grate/Utility Type	
		N/A			N/A
		Yes		Surface Condition? (G/P)	Good

Remove & Replace Curb Ramp With Two New Directional Ramps or Equivalent.
