# Access Compliance Report

## Public Rights-of-Way

### (Curb Ramps)

Intersection ID: 12401	Main Street: MIDWOOD_PL	Cross Street: TIPPAH_AV	Location: SE
ADA ID: FF6CE8A9782F	Ramp Type: PerpDiag	Initial Pass/Fail: Fail	Overall Compliance: No
		Severity Score: 12.5

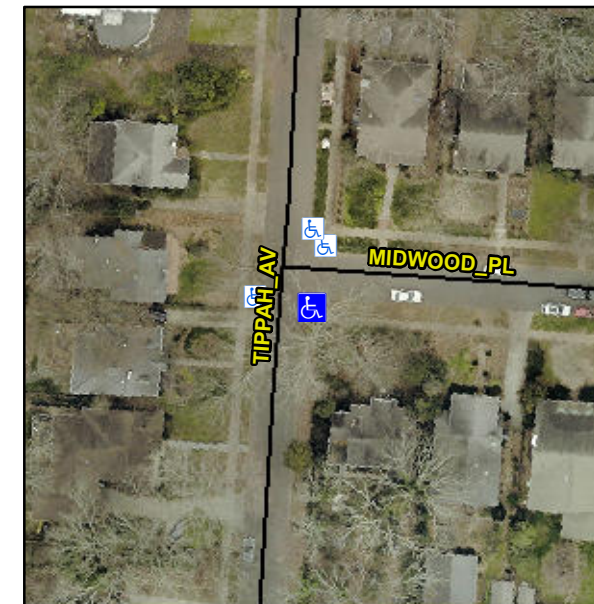
**Not Found, R304.2.2**

Compliance	Description	Data	Compliance	Description	Data
N/A	Ramp Length (in)	112.0	No	Ramp Slope (%)	8.7
Yes	Ramp Width (in)	57.0	Yes	Ramp XSlope (%)	0.9
N/A	Flare Type LT	N/A	N/A	Flare Type RT	N/A
N/A	Flare Slope LT (%)	N/A	N/A	Flare Slope RT (%)	N/A
N/A	Flare Traversable LT?	N/A	N/A	Flare Traversable RT?	N/A
N/A	Landing Length (in)	N/A	N/A	DWS Provided?	N/A
N/A	Landing Width (in)	N/A	N/A	DWS Contrast?	N/A
N/A	Landing Slope (%)	N/A	N/A	DWS Length (in)	N/A
N/A	Landing X Slope (%)	N/A	N/A	DWS Full Width?	N/A
N/A	Landing Curb? (Y/N)	N/A	N/A	DWS Offset (in)	N/A
N/A	Shared Landing?	N/A			
N/A	Gutter Ponding?	Yes	N/A	Gutter Slope (%)	N/A
N/A	Gutter Lip Ht (in)	N/A	N/A	Gutter X Slope (%)	N/A
N/A	Painted X Walk1?	No	N/A	Painted X Walk2?	No
	X Walk 1 Direction	To N		X Walk 2 Direction	To W
N/A	X Walk 1 Width (in)	N/A	N/A	X Walk 2 Width (in)	N/A
	X Walk 1 Slope (%)	6.5		X Walk 2 Slope (%)	0.1
	X Walk 1 X Slope (%)	1.3		X Walk 2 X Slope (%)	3.1

N/A	Ramp inside XWalk1?	N/A	N/A	Ramp inside XWalk2?	N/A
	Road Slope (%)	1.4	N/A	Clear Space?	N/A
	Road X Slope (%)	4.8	N/A	Clear Space to XWalk (in)	N/A
N/A	Any Obstructions?	N/A	N/A	Storm Grate/Utility Hazard?	N/A
	Obstruction Type			Storm Grate/Utility Type	
		N/A			N/A
		Yes		Surface Condition? (G/P)	Good

**Remove & Replace Curb Ramp With Two New Directional Ramps or Equivalent.**

Total Cost: \$ 3200.00
