# Access Compliance Report

## Public Rights-of-Way

### (Curb Ramps)

Intersection ID: 54117	Main Street: COLIN_CROSSING_CT	Cross Street: ENDAHVEN_VILLAGE_DR	Location: NW
ADA ID: FF78946D761F	Ramp Type: PerpDiag	Initial Pass/Fail: Fail	Overall Compliance: No
Severity Score: 22.5			
Codes/Mitigation Info/Possible Solution		Field Measurements/Component Compliance

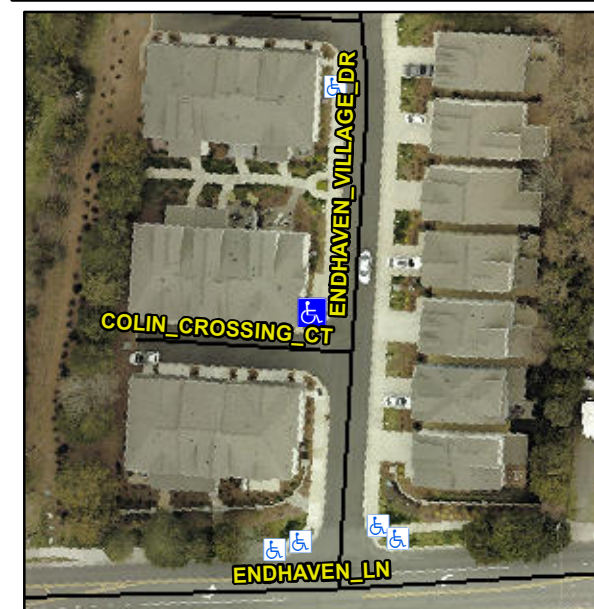
Compliance	Description	Data	Compliance	Description	Data
N/A	Ramp Length (in)	50.0	No	Ramp Slope (%)	9.2
No	Ramp Width (in)	46.0	No	Ramp XSlope (%)	3.5
N/A	Flare Type LT	N/A	N/A	Flare Type RT	N/A
N/A	Flare Slope LT (%)	N/A	N/A	Flare Slope RT (%)	N/A
N/A	Flare Traversable LT?	N/A	N/A	Flare Traversable RT?	N/A
N/A	Landing Length (in)	N/A	N/A	DWS Provided?	N/A
N/A	Landing Width (in)	N/A	N/A	DWS Contrast?	N/A
N/A	Landing Slope (%)	N/A	N/A	DWS Length (in)	N/A
N/A	Landing X Slope (%)	N/A	N/A	DWS Full Width?	N/A
N/A	Landing Curb? (Y/N)	N/A	N/A	DWS Offset (in)	N/A
N/A	Shared Landing?	N/A			
N/A	Gutter Ponding?	N/A	N/A	Gutter Slope (%)	N/A
N/A	Gutter Lip Ht (in)	N/A	N/A	Gutter X Slope (%)	N/A
N/A	Painted X Walk1?	No	N/A	Painted X Walk2?	No
	X Walk 1 Direction	To S		X Walk 2 Direction	To E
N/A	X Walk 1 Width (in)	N/A	N/A	X Walk 2 Width (in)	N/A
	X Walk 1 Slope (%)	2.4		X Walk 2 Slope (%)	0.3
	X Walk 1 X Slope (%)	0.6		X Walk 2 X Slope (%)	2.4

N/A	Ramp inside XWalk1?	N/A	N/A	Ramp inside XWalk2?	N/A
	Road Slope (%)	0.1	N/A	Clear Space?	N/A
	Road X Slope (%)	1.5	N/A	Clear Space to XWalk (in)	N/A
N/A	Any Obstructions?	N/A	N/A	Storm Grate/Utility Hazard?	N/A
	Obstruction Type			Storm Grate/Utility Type	
		N/A			N/A
		Yes		Surface Condition? (G/P)	Good

**Remove & Replace Curb Ramp With Two New Directional Ramps or Equivalent.**

**R304.5.1, R304.2.2, R304.5.3**

Total Cost: \$ 3200.00
