## **Access Compliance Report Public Rights-of-Way** (Curb Ramps)

Intersection ID: 48984 Main Street: ASHTON\_GATE\_DR Cross Street: KINGSDOWN\_AV Location: NW **Overall Compliance: No** Severity Score: **ADA ID: FF8E53848ED5** Ramp Type: Perp Initial Pass/Fail: Fail 8.75

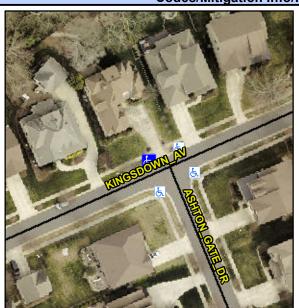
Field Measurements/Component Compliance								
Comp	iance Description	Data	Compli	ance	Description	Data		
N/A	Ramp Length (in)	72.0	Yes	Ramp	Slope (%)	6.5		
No	Ramp Width (in)	46.5	Yes	Ramp	XSlope (%)	1.3		
N/A	Flare Type LT	N/A	N/A	Flare	Type RT	N/A		
N/A	Flare Slope LT (%)	N/A	N/A	Flare	Slope RT (%)	N/A		
N/A	Flare Traversable LT?	N/A	N/A	Flare	Traversable RT?	N/A		
N/A	Landing Length (in)	N/A	N/A	DWS	Provided?	N/A		
N/A	Landing Width (in)	N/A	N/A	DWS	Contrast?	N/A		
N/A	Landing Slope (%)	N/A	N/A	DWS	Length (in)	N/A		
N/A	Landing X Slope (%)	N/A	N/A	DWS	Full Width?	N/A		
N/A	Landing Curb? (Y/N)	N/A	N/A	DWS	Offset (in)	N/A		
N/A	Shared Landing?	N/A						
N/A	Gutter Ponding?	N/A	N/A	Gutte	r Slope (%)	N/A		
N/A	Gutter Lip Ht (in)	N/A	N/A	Gutte	r X Slope (%)	N/A		
N/A	Painted X Walk1?	No	N/A	Painte	ed X Walk2?	N/A		
	X Walk 1 Direction	To S		X Wal	lk 2 Direction	N/A		
N/A	X Walk 1 Width (in)	N/A	N/A	X Wal	lk 2 Width (in)	N/A

Possible Solutions:	Col
Remove & Replace Entire Ramp.	N/A
·	No
	N/A
	N/A
	N/A
	N/A
Surveyor Notes:	N/A
N/A	N/A
	N/A
	N/A
	N/A
PROW/ADA:	N/A
Not Found, R304.5.1	N/A
	N/A
	N/A
	N/A

Total Cost:	\$ 1850.00
