# Access Compliance Report

## Public Rights-of-Way

### (Curb Ramps)

| Intersection ID: 7207 | Main Street: HOPE_VALLEY_LN | Cross Street: KINGVILLE_DR | Location: | E |

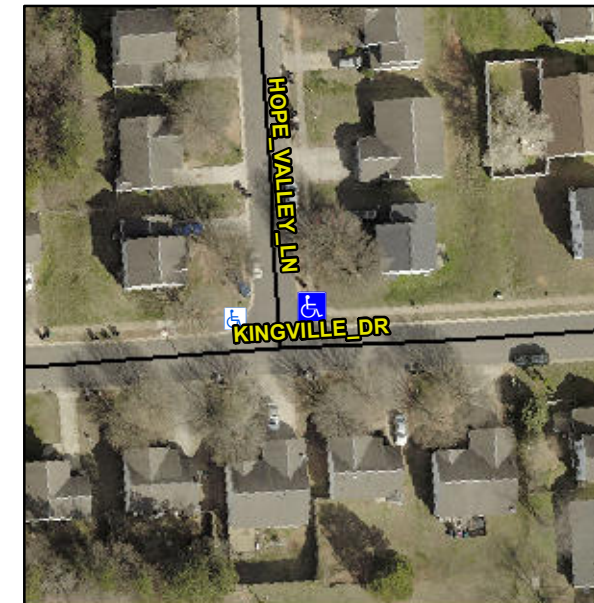
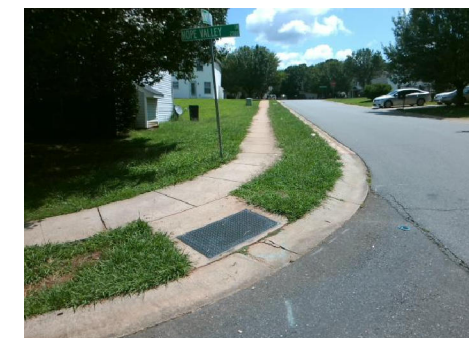
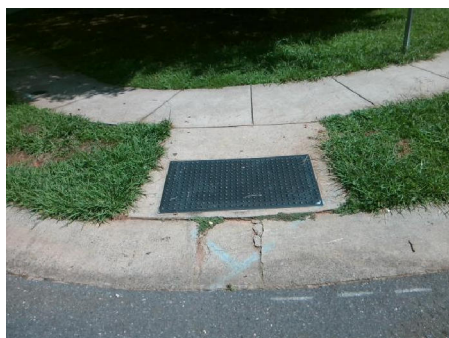
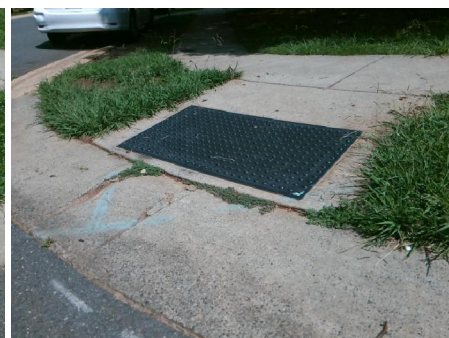
| ADA ID: FF9475F2689F | Ramp Type: Perp | Initial Pass/Fail: Fail | Overall Compliance: No | Severity Score: 50 |

**Not Found, R304.2.2, R304.5.3**

| Compliance | Description | Data | Compliance | Description | Data |
|---|---|---|---|---|---|
| N/A | Ramp Length (in) | 50.5 | No | Ramp Slope (%) | 14.0 |
| Yes | Ramp Width (in) | 60.0 | No | Ramp XSlope (%) | 8.4 |

**Remove & Replace Entire Ramp.**

**\$ 1850.00**
