# Access Compliance Report

## Public Rights-of-Way

### (Curb Ramps)

Intersection ID: 18557	Main Street: MILFORD_RD	Cross Street: SENECA_PL	Location: SW
ADA ID: FF9D4125FCAE	Ramp Type: PerpDiag	Initial Pass/Fail: Fail	Overall Compliance: No
		Severity Score: 25

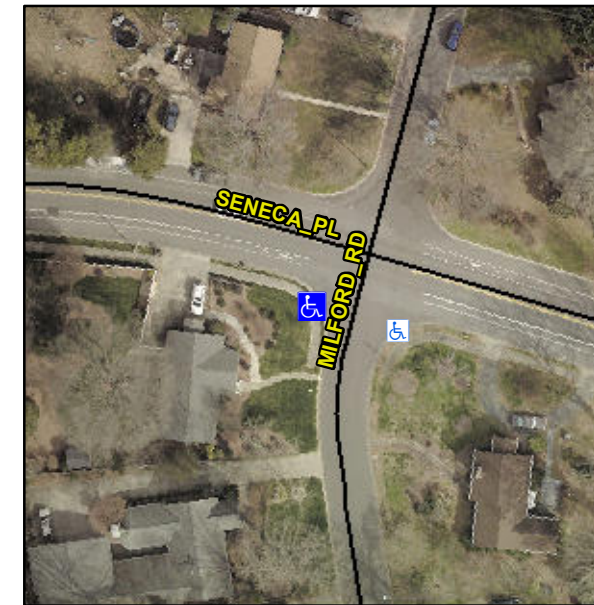
**Not Found, R304.5.3**

Compliance	Description	Data	Compliance	Description	Data
N/A	Ramp Length (in)	84.0	Yes	Ramp Slope (%)	5.1
Yes	Ramp Width (in)	48.0	No	Ramp XSlope (%)	7.2
N/A	Flare Type LT	N/A	N/A	Flare Type RT	N/A
N/A	Flare Slope LT (%)	N/A	N/A	Flare Slope RT (%)	N/A
N/A	Flare Traversable LT?	N/A	N/A	Flare Traversable RT?	N/A
N/A	Landing Length (in)	N/A	N/A	DWS Provided?	N/A
N/A	Landing Width (in)	N/A	N/A	DWS Contrast?	N/A
N/A	Landing Slope (%)	N/A	N/A	DWS Length (in)	N/A
N/A	Landing X Slope (%)	N/A	N/A	DWS Full Width?	N/A
N/A	Landing Curb? (Y/N)	N/A	N/A	DWS Offset (in)	N/A
N/A	Shared Landing?	N/A			
N/A	Gutter Ponding?	N/A	N/A	Gutter Slope (%)	N/A
N/A	Gutter Lip Ht (in)	N/A	N/A	Gutter X Slope (%)	N/A
N/A	Painted X Walk1?	No	N/A	Painted X Walk2?	No
	X Walk 1 Direction	To SE		X Walk 2 Direction	To NE
N/A	X Walk 1 Width (in)	N/A	N/A	X Walk 2 Width (in)	N/A
	X Walk 1 Slope (%)	0.7		X Walk 2 Slope (%)	2.2
	X Walk 1 X Slope (%)	3.5		X Walk 2 X Slope (%)	2.5

N/A	Ramp inside XWalk1?	N/A	N/A	Ramp inside XWalk2?	N/A
	Road Slope (%)	5.3	N/A	Clear Space?	N/A
	Road X Slope (%)	2.6	N/A	Clear Space to XWalk (in)	N/A
N/A	Any Obstructions?	N/A	N/A	Storm Grate/Utility Hazard?	N/A
	Obstruction Type			Storm Grate/Utility Type	
		N/A			N/A
			Yes	Surface Condition? (G/P)	Good

**Remove & Replace Curb Ramp With Two New Directional Ramps or Equivalent.**

Total Cost: \$ 3200.00
