Access Compliance Report

Public Rights-of-Way

(Curb Ramps)

Intersection ID: 29818	Main Street: WEDGEWOOD COMMONS DR	Cross Street: MINA CT	Location: SW
ADA ID: FF9D7B242FC3	Ramp Type: PerpDiag	Initial Pass/Fail: Fail	Overall Compliance: No
Codes/Mitigation Info/Possible Solution		Field Measurements/Component Compliance

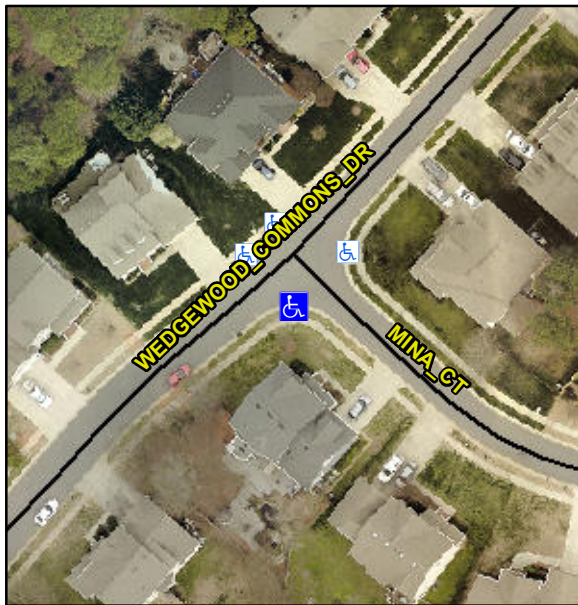
R304.2.2, R304.5.3

Compliance	Description	Data	Compliance	Description	Data
N/A	Ramp Length (in)	47.0	No	Ramp Slope (%)	8.9
Yes	Ramp Width (in)	48.0	No	Ramp XSlope (%)	5.0
N/A	Flare Type LT	N/A	N/A	Flare Type RT	N/A
N/A	Flare Slope LT (%)	N/A	N/A	Flare Slope RT (%)	N/A
N/A	Flare Traversable LT?	N/A	N/A	Flare Traversable RT?	N/A
N/A	Landing Length (in)	N/A	N/A	DWS Provided?	N/A
N/A	Landing Width (in)	N/A	N/A	DWS Contrast?	N/A
N/A	Landing Slope (%)	N/A	N/A	DWS Length (in)	N/A
N/A	Landing X Slope (%)	N/A	N/A	DWS Full Width?	N/A
N/A	Landing Curb? (Y/N)	N/A	N/A	DWS Offset (in)	N/A
N/A	Shared Landing?	N/A			
N/A	Gutter Ponding?	N/A	N/A	Gutter Slope (%)	N/A
N/A	Gutter Lip Ht (in)	N/A	N/A	Gutter X Slope (%)	N/A
N/A	Painted X Walk1?	No	N/A	Painted X Walk2?	No
	X Walk 1 Direction	To NE		X Walk 2 Direction	To NW
N/A	X Walk 1 Width (in)	N/A	N/A	X Walk 2 Width (in)	N/A
	X Walk 1 Slope (%)	1.7		X Walk 2 Slope (%)	1.9
	X Walk 1 X Slope (%)	2.4		X Walk 2 X Slope (%)	3.4

N/A	Ramp inside XWalk1?	N/A	N/A	Ramp inside XWalk2?	N/A
	Road Slope (%)	5.3	N/A	Clear Space?	N/A
	Road X Slope (%)	1.5	N/A	Clear Space to XWalk (in)	N/A
N/A	Any Obstructions?	N/A	N/A	Storm Grate/Utility Hazard?	N/A
	Obstruction Type			Storm Grate/Utility Type	
		N/A			N/A
			Yes	Surface Condition? (G/P)	Good

Remove & Replace Curb Ramp With Two New Directional Ramps or Equivalent.

Total Cost: \$ 3200.00

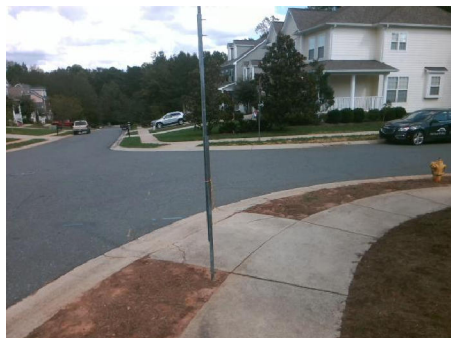
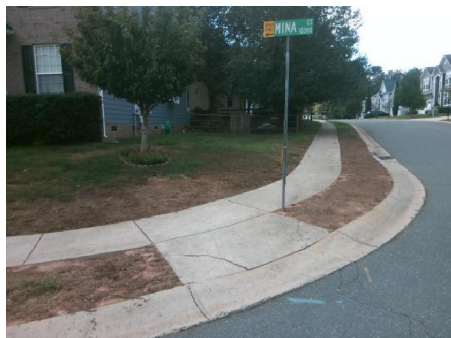
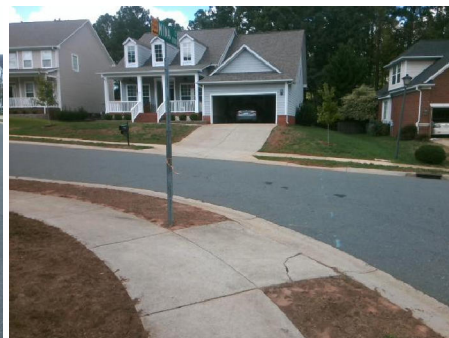
Street 1 Name MINA CT
 Stop Condition-Street 2 StopSign
 Street 2 Name WEDGEWOOD COMMONS DR
 Stop Condition-Street 1 None
