## **Access Compliance Report Public Rights-of-Way** (Curb Ramps)

Intersection ID: 28240 Main Street: FORTBRIDGE LN Cross Street: SUMMER\_CLUB\_RD Location: SE **ADA ID: FFB70F42B516** Ramp Type: BlendTrans2 Initial Pass/Fail: Fail **Overall Compliance: No Severity Score:** 12.5

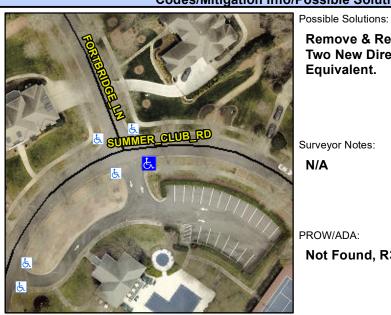
Not Found, R304.5.3

Field Measurements/Component Compliance					
Compliance Description Da		Data	Comp	liance Description	Data
N/A	Ramp Length (in)	145.5	Yes	BlendTrans Slope (%)	3.0
Yes	Ramp Width (in)	53.0	No	BlendTrans XSlope (%)	5.1
N/A	Flare Type LT	N/A	N/A	Flare Type RT	N/A
N/A	Flare Slope LT (%)	N/A	N/A	Flare Slope RT (%)	N/A
N/A	Flare Traversable LT?	N/A	N/A	Flare Traversable RT?	N/A
N/A	Landing Length (in)	N/A	N/A	DWS Provided?	N/A
N/A	Landing Width (in)	N/A	N/A	DWS Contrast?	N/A
N/A	Landing Slope (%)	N/A	N/A	DWS Length (in)	N/A
N/A	Landing X Slope (%)	N/A	N/A	DWS Full Width?	N/A
N/A	Landing Curb? (Y/N)	N/A	N/A	DWS Offset (in)	N/A
N/A	Shared Landing?	N/A			
N/A	Gutter Ponding?	N/A	N/A	Gutter Slope (%)	N/A
N/A	Gutter Lip Ht (in)	N/A	N/A	Gutter X Slope (%)	N/A
N/A	Painted X Walk1?	No	N/A	Painted X Walk2?	No
	X Walk 1 Direction	To NW		X Walk 2 Direction	To SW
	X Walk 1 Width (in)	N/A		X Walk 2 Width (in)	N/A
	X Walk 1 Slope (%)	1.8		X Walk 2 Slope (%)	2.7

X Walk 1 X Slope (%)	1.5		X Walk 2 X Slope (%)	1.4
N/A	Ramp inside XWalk1?	N/A	N/A	Ramp inside XWalk2?	N/A
	Road Slope (%)	3.1		Clear Space?	N/A
	Road X Slope (%)	2.6	N/A	Clear Space to XWalk (in)	N/A
N/A	Any Obstructions?	N/A	N/A	Storm Grate/Utility Hazard?	N/A
	Obstruction Type			Storm Grate/Utility Type	
		N/A			N/A
			Yes	Surface Condition? (G/P)	Good
<b>1</b>			No	Curb Slope (%)	17.9

**Remove & Replace Curb Ramp With Two New Directional Ramps or** Equivalent.
