Access Compliance Report

Public Rights-of-Way

(Curb Ramps)

Intersection ID: 18797	Main Street: SENECA_PL	Cross Street: WEDGEWOOD_DR	Location: NW
ADA ID: FFBA69A1B506	Ramp Type: Perp	Initial Pass/Fail: Fail	Overall Compliance: No
		Severity Score: 12.5

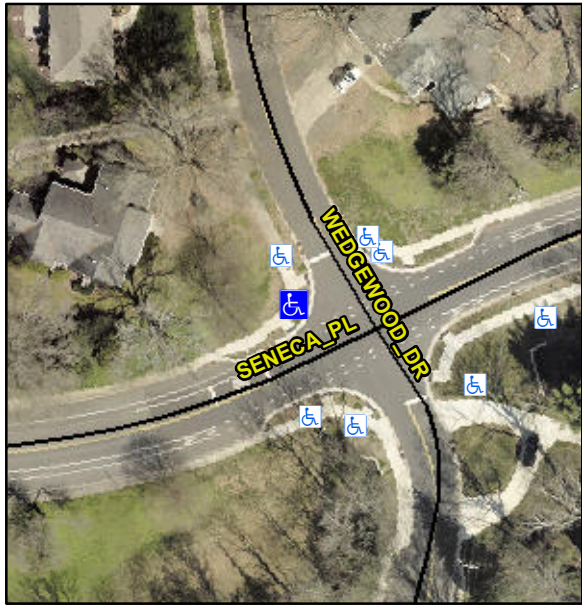
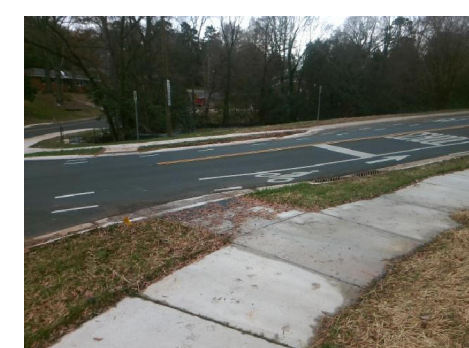
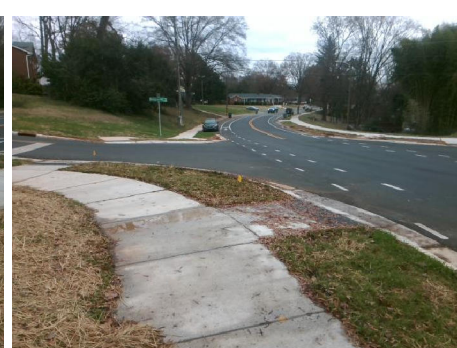
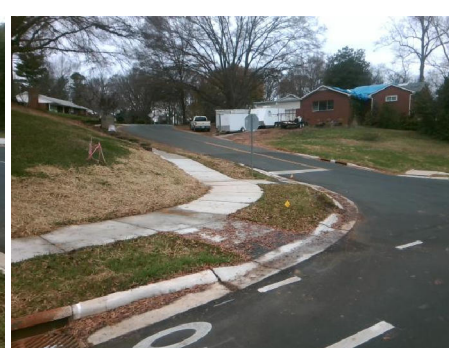
Possible Solutions:		Compliance	Description	Data	Compliance	Description	Data
	Remove & Replace Entire Ramp.		N/A	Ramp Length (in)	73.0	No	Ramp Slope (%)	9.3
			Yes	Ramp Width (in)	72.0	Yes	Ramp XSlope (%)	0.5
			N/A	Flare Type LT	N/A	N/A	Flare Type RT	N/A
			N/A	Flare Slope LT (%)	N/A	N/A	Flare Slope RT (%)	N/A
			N/A	Flare Traversable LT?	N/A	N/A	Flare Traversable RT?	N/A
			N/A	Landing Length (in)	N/A	N/A	DWS Provided?	N/A
			N/A	Landing Width (in)	N/A	N/A	DWS Contrast?	N/A
			N/A	Landing Slope (%)	N/A	N/A	DWS Length (in)	N/A
			N/A	Landing X Slope (%)	N/A	N/A	DWS Full Width?	N/A
<p>Surveyor Notes:</p> <p>N/A</p> <p>PROW/ADA:</p> <p>Not Found, R304.2.2</p>			N/A	Landing Curb? (Y/N)	N/A	N/A	DWS Offset (in)	N/A
			N/A	Shared Landing?	N/A			
			N/A	Gutter Ponding?	N/A	N/A	Gutter Slope (%)	N/A
			N/A	Gutter Lip Ht (in)	N/A	N/A	Gutter X Slope (%)	N/A

N/A	Painted X Walk1?	No	N/A	Painted X Walk2?	N/A
				X Walk 1 Direction	To S		X Walk 2 Direction	N/A
			N/A	X Walk 1 Width (in)	N/A	N/A	X Walk 2 Width (in)	N/A
				X Walk 1 Slope (%)	2.9		X Walk 2 Slope (%)	N/A
				X Walk 1 X Slope (%)	2.5		X Walk 2 X Slope (%)	N/A
			N/A	Ramp inside XWalk1?	N/A	N/A	Ramp inside XWalk2?	N/A
<p>Total Cost:</p> <p>\$ 1850.00</p>				Road Slope (%)	N/A	N/A	Clear Space?	N/A
				Road X Slope (%)	N/A	N/A	Clear Space to XWalk (in)	N/A
			N/A	Any Obstructions?	N/A	N/A	Storm Grate/Utility Hazard?	N/A
				Obstruction Type			Storm Grate/Utility Type	
					N/A			N/A
						Yes	Surface Condition? (G/P)	Good
