Access Compliance Report

Public Rights-of-Way

(Curb Ramps)

Intersection ID: 21411	Main Street: MONROE_RD	Cross Street: SARDIS_RD_NORTH	Location: SW
ADA ID: FFBBFE2DFC69	Ramp Type: Para	Initial Pass/Fail: Fail	Overall Compliance: No
		Severity Score: 12.5

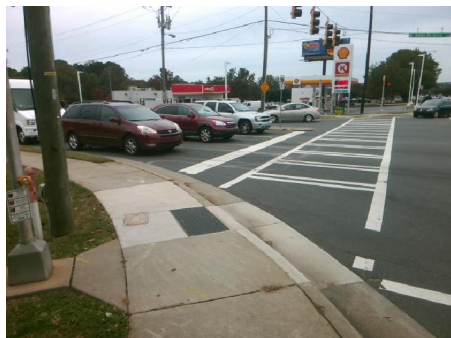
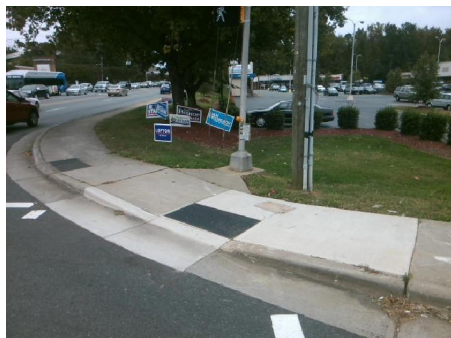
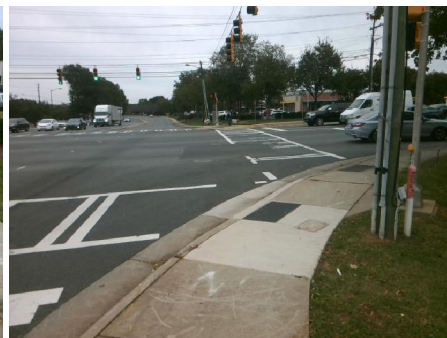
RT RP < 5%

Compliance	Description	Data	Compliance	Description	Data
N/A	Ramp Length LT (in)	64.0	N/A	Ramp Length RT (in)	65.0
Yes	Ramp Width LT (in)	59.0	Yes	Ramp Width RT (in)	60.0
No	Ramp Slope LT (%)	9.2	Yes	Ramp Slope RT (%)	3.6
Yes	Ramp XSlope LT (%)	1.2	Yes	Ramp XSlope RT (%)	0.2
N/A	Landing Length (in)	N/A	N/A	DWS Provided?	N/A
N/A	Landing Width (in)	N/A	N/A	DWS Contrast?	N/A
N/A	Landing Slope (%)	N/A	N/A	DWS Length (in)	N/A
N/A	Landing X Slope (%)	N/A	N/A	DWS Full Width?	N/A
N/A	Landing Curb? (Y/N)	N/A	N/A	DWS Offset (in)	N/A
N/A	Shared Landing?	N/A			
N/A	Gutter Ponding?	N/A	N/A	Gutter Slope (%)	N/A
N/A	Gutter Lip Ht (in)	N/A	N/A	Gutter X Slope (%)	N/A
N/A	Painted X Walk1?	Yes	N/A	Painted X Walk2?	N/A
	X Walk 1 Direction	To NW		X Walk 2 Direction	N/A
N/A	X Walk 1 Width (in)	111.0	N/A	X Walk 2 Width (in)	N/A
	X Walk 1 Slope (%)	2.6		X Walk 2 Slope (%)	N/A
	X Walk 1 X Slope (%)	1.3		X Walk 2 X Slope (%)	N/A
N/A	Ramp inside XWalk1?	Yes	N/A	Ramp inside XWalk2?	N/A

Road Slope (%)	N/A	N/A	Clear Space?	N/A
	Road X Slope (%)	N/A	N/A	Clear Space to XWalk (in)	N/A
N/A	Any Obstructions?	N/A	N/A	Storm Grate/Utility Hazard?	N/A
	Obstruction Type			Storm Grate/Utility Type	
		N/A			N/A
			Yes	Surface Condition? (G/P)	Good
			N/A	Curb Slope (%)	7.3

Remove & Replace Entire Ramp.
