Access Compliance Report

Public Rights-of-Way

(Curb Ramps)

Intersection ID: 23966	Main Street: CAROLINA_PAVILION_DR_N	Cross Street: SOUTH_BV	Location: NE
ADA ID: FFCFAB703E34	Ramp Type: Perp	Initial Pass/Fail: Fail	Overall Compliance: No
		Severity Score: 12.5

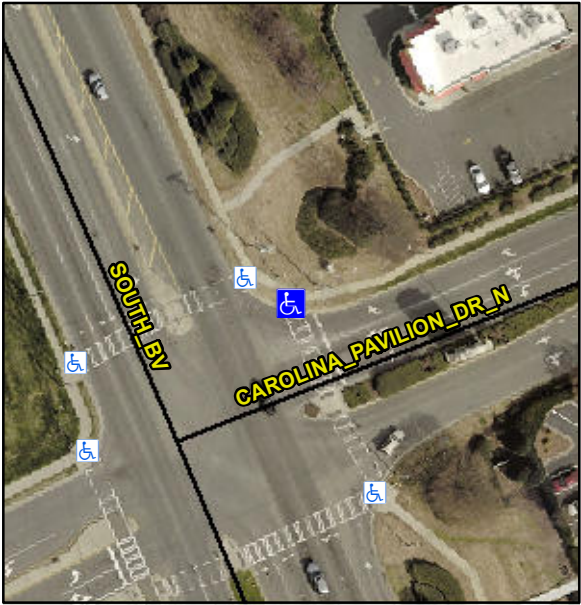
Possible Solutions:		Compliance	Description	Data
	Remove & Replace Entire Ramp.		No	Ramp Length (in)	72.0
			Yes	Ramp Width (in)	48.0
			N/A	Flare Type LT	N/A
			N/A	Flare Slope LT (%)	N/A
			N/A	Flare Traversable LT?	N/A
			N/A	Landing Length (in)	N/A
			N/A	Landing Width (in)	N/A
			N/A	Landing Slope (%)	N/A
			N/A	Landing X Slope (%)	N/A
			N/A	Landing Curb? (Y/N)	N/A
			N/A	Shared Landing?	N/A
			N/A	Gutter Ponding?	N/A
			N/A	Gutter Lip Ht (in)	N/A
			N/A	Painted X Walk1?	Yes
				X Walk 1 Direction	To S
			N/A	X Walk 1 Width (in)	98.0
				X Walk 1 Slope (%)	3.3
				X Walk 1 X Slope (%)	0.2
			N/A	Ramp inside XWalk1?	Yes
<p>Surveyor Notes:</p> <p>N/A</p> <p>PROW/ADA:</p> <p>Not Found, R304.2.2</p>			N/A	Flare Type RT	N/A
			N/A	Flare Slope RT (%)	N/A
			N/A	Flare Traversable RT?	N/A
			N/A	DWS Provided?	N/A
			N/A	DWS Contrast?	N/A

N/A	DWS Length (in)	N/A
			N/A	DWS Full Width?	N/A
			N/A	DWS Offset (in)	N/A
			N/A	Gutter Slope (%)	N/A
			N/A	Gutter X Slope (%)	N/A
			N/A	Painted X Walk2?	N/A
				X Walk 2 Direction	N/A
			N/A	X Walk 2 Width (in)	N/A
				X Walk 2 Slope (%)	N/A
				X Walk 2 X Slope (%)	N/A
			N/A	Ramp inside XWalk2?	N/A
			N/A	Clear Space?	N/A
			N/A	Clear Space to XWalk (in)	N/A
			N/A	Storm Grate/Utility Hazard?	N/A
				Storm Grate/Utility Type	
<p>Total Cost:</p> <p>\$ 1850.00</p>			N/A		N/A
			Yes	Surface Condition? (G/P)	Good
