Access Compliance Report

Public Rights-of-Way

(Curb Ramps)

Intersection ID: 20292	Main Street: BENTLEY_OAKS_LN	Cross Street: SARDIS_RD	Location: NE
ADA ID: FFD421989681	Ramp Type: Perp	Initial Pass/Fail: Fail	Overall Compliance: No
Severity Score: 13.75			
Codes/Mitigation Info/Possible Solution		Field Measurements/Component Compliance

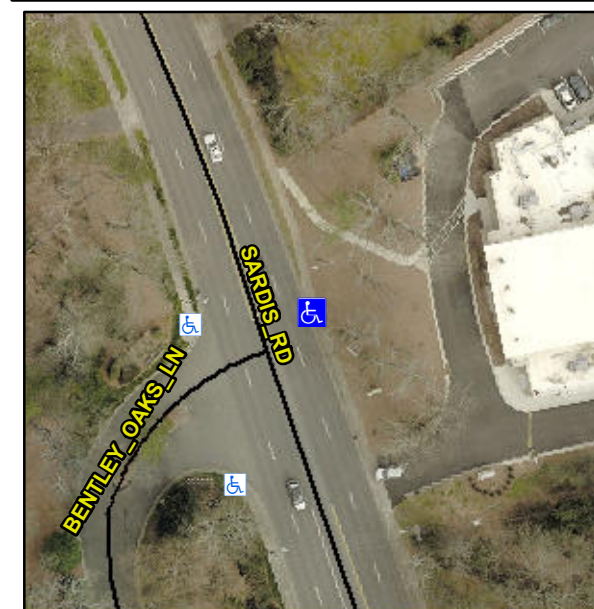
Not Found, R304.2.2

Compliance	Description	Data	Compliance	Description	Data
N/A	Ramp Length (in)	60.0	No	Ramp Slope (%)	9.2
Yes	Ramp Width (in)	49.0	Yes	Ramp XSlope (%)	3.0
N/A	Flare Type LT	N/A	N/A	Flare Type RT	N/A
N/A	Flare Slope LT (%)	N/A	N/A	Flare Slope RT (%)	N/A
N/A	Flare Traversable LT?	N/A	N/A	Flare Traversable RT?	N/A
N/A	Landing Length (in)	N/A	N/A	DWS Provided?	N/A
N/A	Landing Width (in)	N/A	N/A	DWS Contrast?	N/A
N/A	Landing Slope (%)	N/A	N/A	DWS Length (in)	N/A
N/A	Landing X Slope (%)	N/A	N/A	DWS Full Width?	N/A
N/A	Landing Curb? (Y/N)	N/A	N/A	DWS Offset (in)	N/A
N/A	Shared Landing?	N/A			
N/A	Gutter Ponding?	N/A	N/A	Gutter Slope (%)	N/A
N/A	Gutter Lip Ht (in)	N/A	N/A	Gutter X Slope (%)	N/A
N/A	Painted X Walk1?	No	N/A	Painted X Walk2?	N/A
	X Walk 1 Direction	To W		X Walk 2 Direction	N/A
N/A	X Walk 1 Width (in)	N/A	N/A	X Walk 2 Width (in)	N/A
	X Walk 1 Slope (%)	0.1		X Walk 2 Slope (%)	N/A
	X Walk 1 X Slope (%)	3.4		X Walk 2 X Slope (%)	N/A

N/A	Ramp inside XWalk1?	N/A	N/A	Ramp inside XWalk2?	N/A
	Road Slope (%)	N/A	N/A	Clear Space?	N/A
	Road X Slope (%)	N/A	N/A	Clear Space to XWalk (in)	N/A
N/A	Any Obstructions?	N/A	N/A	Storm Grate/Utility Hazard?	N/A
	Obstruction Type			Storm Grate/Utility Type	
		N/A			N/A
			Yes	Surface Condition? (G/P)	Good

Remove & Replace Entire Ramp.

Total Cost: \$ 1850.00
