Access Compliance Report

(Curb Ramps)

Intersection ID: 20439	Main Street: FAIRVIEW_RD	Cross Street: SHARON_RD	Location: SW
ADA ID: FFD49840EB73	Ramp Type: Perp	Initial Pass/Fail: Fail	Overall Compliance: No
		Severity Score: 12.5

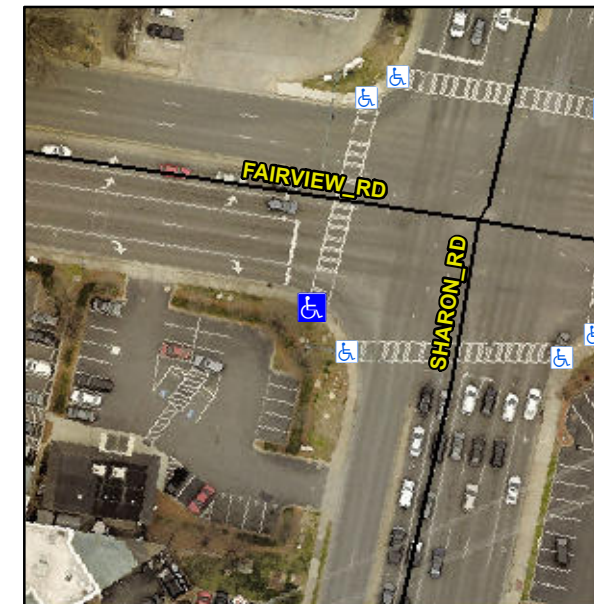
Not Found, R304.2.2

Compliance	Description	Data	Compliance	Description	Data
N/A	Ramp Length (in)	60.0	No	Ramp Slope (%)	9.1
Yes	Ramp Width (in)	48.0	Yes	Ramp XSlope (%)	1.7
N/A	Flare Type LT	N/A	N/A	Flare Type RT	N/A
N/A	Flare Slope LT (%)	N/A	N/A	Flare Slope RT (%)	N/A
N/A	Flare Traversable LT?	N/A	N/A	Flare Traversable RT?	N/A
N/A	Landing Length (in)	N/A	N/A	DWS Provided?	N/A
N/A	Landing Width (in)	N/A	N/A	DWS Contrast?	N/A
N/A	Landing Slope (%)	N/A	N/A	DWS Length (in)	N/A
N/A	Landing X Slope (%)	N/A	N/A	DWS Full Width?	N/A
N/A	Landing Curb? (Y/N)	N/A	N/A	DWS Offset (in)	N/A
N/A	Shared Landing?	N/A			
N/A	Gutter Ponding?	N/A	N/A	Gutter Slope (%)	N/A
N/A	Gutter Lip Ht (in)	N/A	N/A	Gutter X Slope (%)	N/A
N/A	Painted X Walk1?	Yes	N/A	Painted X Walk2?	N/A
	X Walk 1 Direction	To NE		X Walk 2 Direction	N/A
N/A	X Walk 1 Width (in)	112.0	N/A	X Walk 2 Width (in)	N/A
	X Walk 1 Slope (%)	0.6		X Walk 2 Slope (%)	N/A
	X Walk 1 X Slope (%)	0.0		X Walk 2 X Slope (%)	N/A

N/A	Ramp inside XWalk1?	Yes	N/A	Ramp inside XWalk2?	N/A
	Road Slope (%)	N/A	N/A	Clear Space?	N/A
	Road X Slope (%)	N/A	N/A	Clear Space to XWalk (in)	N/A
N/A	Any Obstructions?	N/A	N/A	Storm Grate/Utility Hazard?	N/A
	Obstruction Type			Storm Grate/Utility Type	
		N/A			N/A
		Yes		Surface Condition? (G/P)	Good

Possible Solutions:

Remove & Replace Entire Ramp.
