Access Compliance Report

Public Rights-of-Way

(Curb Ramps)

Intersection ID: N/A	Main Street: BONNY BRIDGE CT	Cross Street: N/A	Location: S
ADA ID: FFE6114EC08F	Ramp Type: BlendTrans1	Initial Pass/Fail: Fail	Overall Compliance: No
Codes/Mitigation Info/Possible Solution		Field Measurements/Component Compliance	
Severity Score: 10

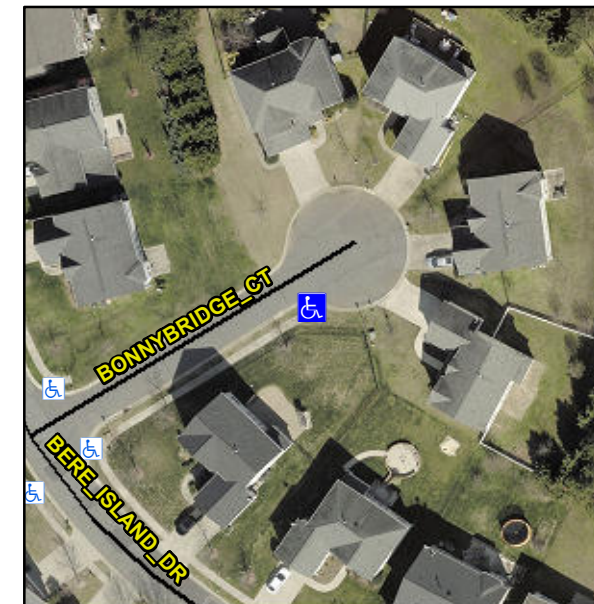
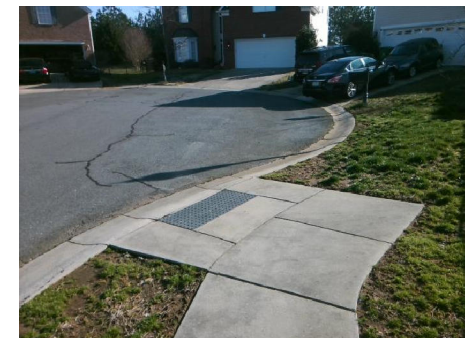
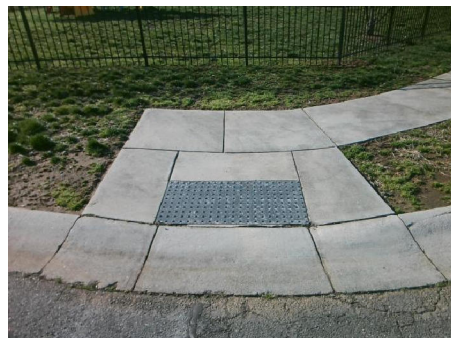
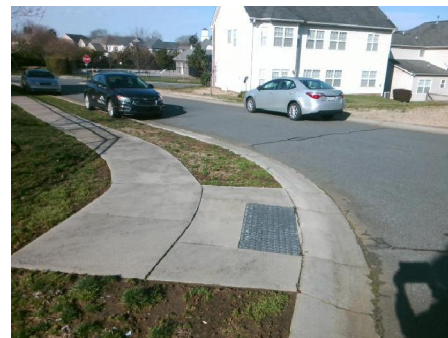
Not Found, R304.5.1, R304.5.3

Compliance	Description	Data	Compliance	Description	Data
N/A	Ramp Length (in)	47.0	Yes	BlendTrans Slope (%)	3.9
No	Ramp Width (in)	45.5	No	BlendTrans XSlope (%)	3.1
N/A	Flare Type LT	N/A	N/A	Flare Type RT	N/A
N/A	Flare Slope LT (%)	N/A	N/A	Flare Slope RT (%)	N/A
N/A	Flare Traversable LT?	N/A	N/A	Flare Traversable RT?	N/A
N/A	Landing Length (in)	N/A	N/A	DWS Provided?	N/A
N/A	Landing Width (in)	N/A	N/A	DWS Contrast?	N/A
N/A	Landing Slope (%)	N/A	N/A	DWS Length (in)	N/A
N/A	Landing X Slope (%)	N/A	N/A	DWS Full Width?	N/A
N/A	Landing Curb? (Y/N)	N/A	N/A	DWS Offset (in)	N/A
N/A	Shared Landing?	N/A			
N/A	Gutter Ponding?	N/A	N/A	Gutter Slope (%)	N/A
N/A	Gutter Lip Ht (in)	N/A	N/A	Gutter X Slope (%)	N/A
N/A	Painted X Walk1?	No	N/A	Painted X Walk2?	N/A
	X Walk 1 Direction	To NW		X Walk 2 Direction	N/A
	X Walk 1 Width (in)	N/A		X Walk 2 Width (in)	N/A
	X Walk 1 Slope (%)	3.7		X Walk 2 Slope (%)	N/A
	X Walk 1 X Slope (%)	1.8		X Walk 2 X Slope (%)	N/A

N/A	Ramp inside XWalk1?	N/A	N/A	Ramp inside XWalk2?	N/A
	Road Slope (%)	1.8		Clear Space?	N/A
	Road X Slope (%)	3.7	N/A	Clear Space to XWalk (in)	N/A
N/A	Any Obstructions?	N/A	N/A	Storm Grate/Utility Hazard?	N/A
	Obstruction Type			Storm Grate/Utility Type	
		N/A			N/A
			Yes	Surface Condition? (G/P)	Good
			No	Curb Slope (%)	13.0

Possible Solutions:

Remove & Replace Curb Ramp With Two New Directional Ramps or Equivalent.
