Access Compliance Report

Public Rights-of-Way

(Curb Ramps)

Intersection ID: 54113	Main Street: BOLING_GREEN_DR	Cross Street: ENDAHVEN_VILLAGE_DR	Location: SE
ADA ID: FFE65FCF771A	Ramp Type: PerpDiag	Initial Pass/Fail: Fail	Overall Compliance: No
		Severity Score: 10

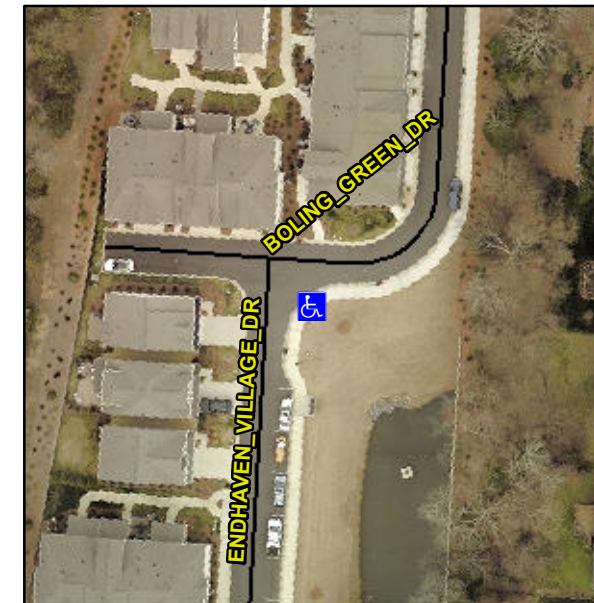
Not Found, R304.5.1, R304.5.3

Compliance	Description	Data	Compliance	Description	Data
N/A	Ramp Length (in)	77.0	Yes	Ramp Slope (%)	5.2
No	Ramp Width (in)	47.0	No	Ramp XSlope (%)	2.9
N/A	Flare Type LT	N/A	N/A	Flare Type RT	N/A
N/A	Flare Slope LT (%)	N/A	N/A	Flare Slope RT (%)	N/A
N/A	Flare Traversable LT?	N/A	N/A	Flare Traversable RT?	N/A
N/A	Landing Length (in)	N/A	N/A	DWS Provided?	N/A
N/A	Landing Width (in)	N/A	N/A	DWS Contrast?	N/A
N/A	Landing Slope (%)	N/A	N/A	DWS Length (in)	N/A
N/A	Landing X Slope (%)	N/A	N/A	DWS Full Width?	N/A
N/A	Landing Curb? (Y/N)	N/A	N/A	DWS Offset (in)	N/A
N/A	Shared Landing?	N/A			
N/A	Gutter Ponding?	N/A	N/A	Gutter Slope (%)	N/A
N/A	Gutter Lip Ht (in)	N/A	N/A	Gutter X Slope (%)	N/A
N/A	Painted X Walk1?	No	N/A	Painted X Walk2?	No
	X Walk 1 Direction	To N		X Walk 2 Direction	To W
N/A	X Walk 1 Width (in)	N/A	N/A	X Walk 2 Width (in)	N/A
	X Walk 1 Slope (%)	1.4		X Walk 2 Slope (%)	5.7
	X Walk 1 X Slope (%)	5.0		X Walk 2 X Slope (%)	0.6

N/A	Ramp inside XWalk1?	N/A	N/A	Ramp inside XWalk2?	N/A
	Road Slope (%)	3.0	N/A	Clear Space?	N/A
	Road X Slope (%)	4.0	N/A	Clear Space to XWalk (in)	N/A
N/A	Any Obstructions?	N/A	N/A	Storm Grate/Utility Hazard?	N/A
	Obstruction Type			Storm Grate/Utility Type	
		N/A			N/A
			Yes	Surface Condition? (G/P)	Good

Possible Solutions:

Remove & Replace Curb Ramp With Two New Directional Ramps or Equivalent.
