# Access Compliance Report

## Public Rights-of-Way

### (Curb Ramps)

| Intersection ID: 52521 | Main Street: LORNA_ST | Cross Street: MCCLINTOCK_RD | Location: W |

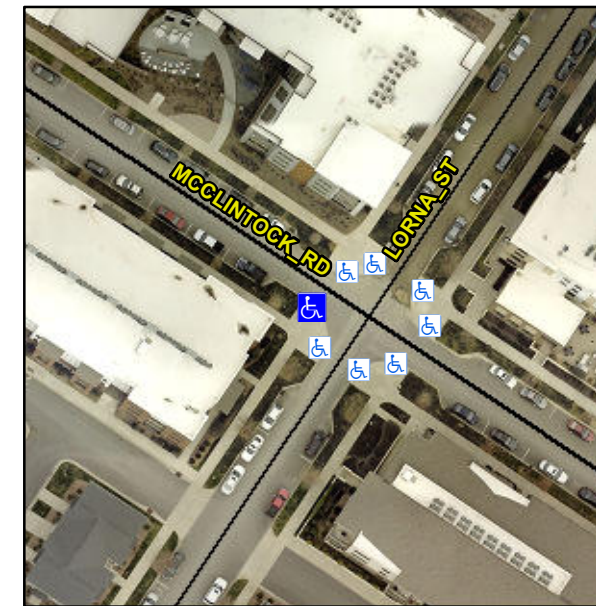
| ADA ID: FFEF070F748A | Ramp Type: BlendTrans1 | Initial Pass/Fail: Pass | Overall Compliance: No |
| Severity Score: 0.25 | | | |

| Compliance | Description | Data | Compliance | Description | Data |
|---|---|---|---|---|---|
| Yes | Ramp Width (in) | 72.0 | No | BlendTrans XSlope (%) | 2.3 |
| No | Landing X Slope (%) | 2.6 | Yes | DWS Full Width? | Yes |
| N/A | Landing Curb? (Y/N) | No | No | DWS Offset (in) | 5.0 |

**Remove & Replace Curb Ramp With Two New Directional Ramps or Equivalent.**

**R304.5.3, R305.2**

Total Cost: \$ 3200.00
